Subject: After-Field Summary Letter Report, Biological Surveys of San Diego County (SDC) Wall Prototype, San Diego County, California, Task Order HSBP1017F00134, Work Order 01

ATTACHMENT A
Project Area Overview Map

ATTACHMENT B
Project Survey Area Maps

ATTACHMENT C
Representative Site Visit Photographs

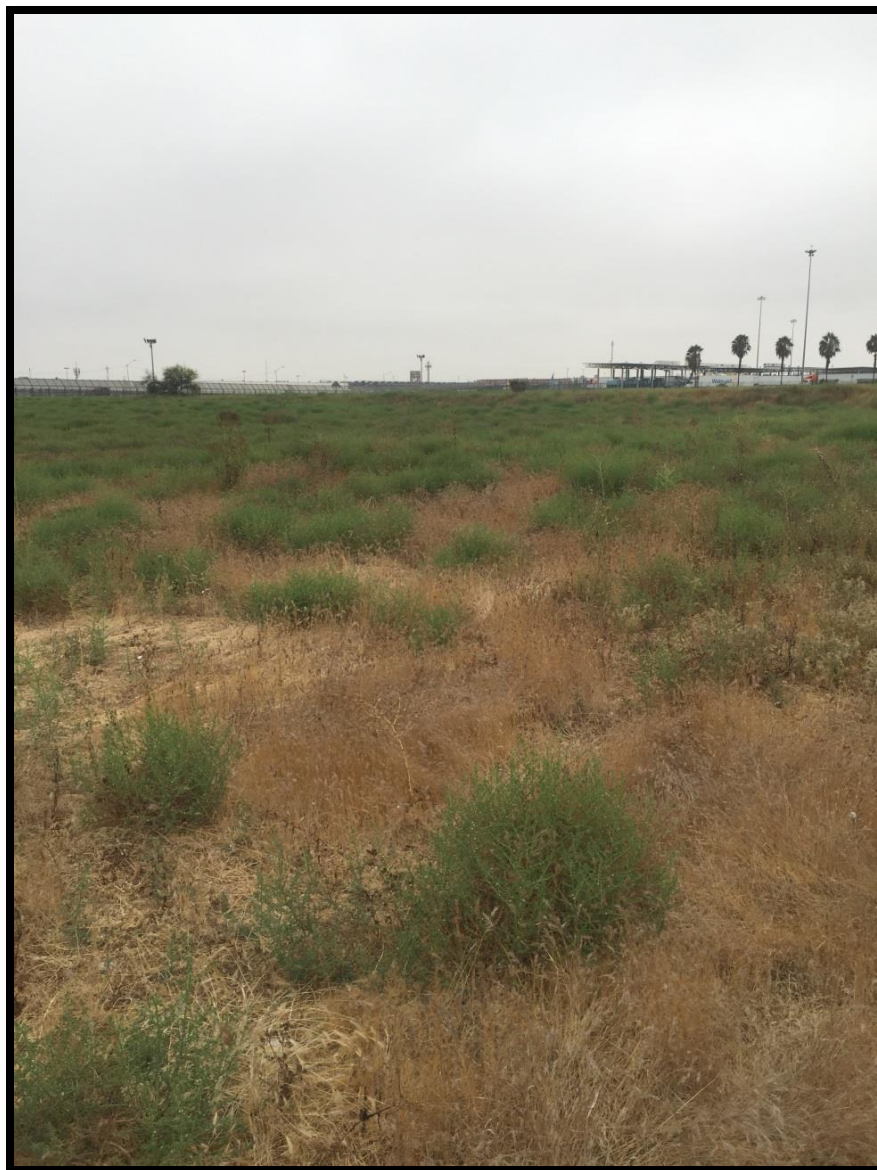
Photograph 1. This image depicts the heavily disturbed landscape within the entry and potential staging area, dominated by non-native species; (looking southwest from northeast corner).

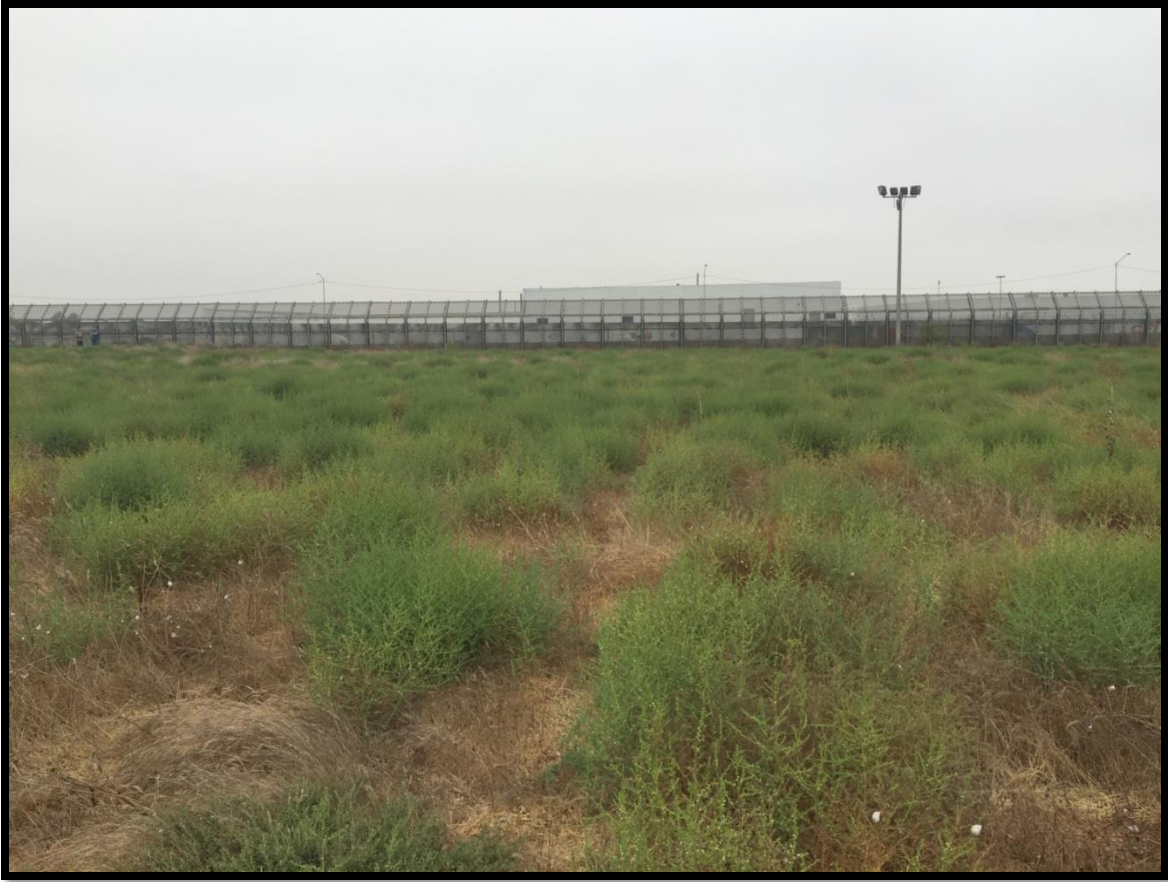
Photograph 2. This image depicts the heavily disturbed landscape within the entry and potential staging area, dominated by non-native species (looking south from an approximate center of survey area).

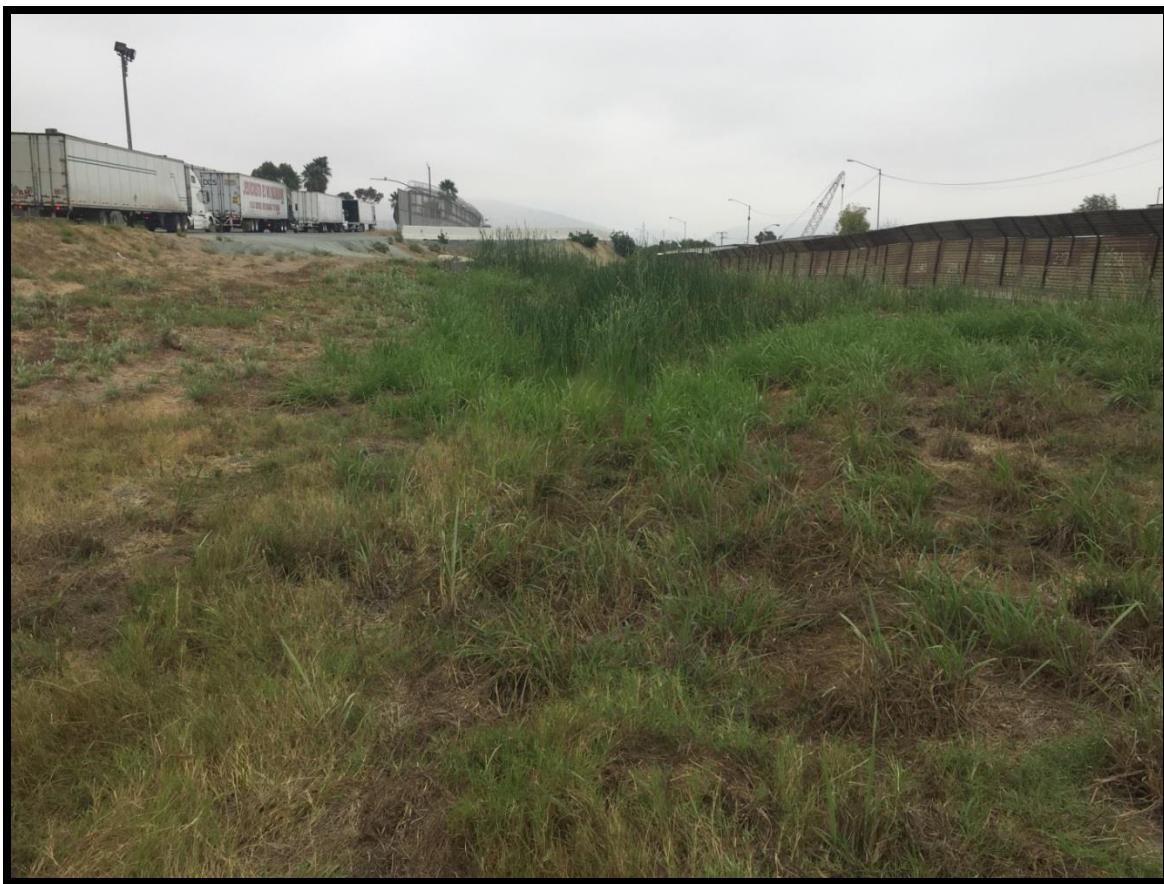
A shallow ditch within the enforcement zone to the east of the entry and potential staging area displayed vegetation and hydrology consistent with wetlands and should be considered as potential wetland habitat (Attachment B, Map 1), (Attachment C, Photographs 3 and 4).

Photograph 3. This image depicts the potential wetland immediately south of the entry and potential staging area (looking east from eastern end of project corridor).

The GSRC biologists identified a potential wetland area south of the entry and potential staging area within the border enforcement zone. This area should be avoided during construction activities.

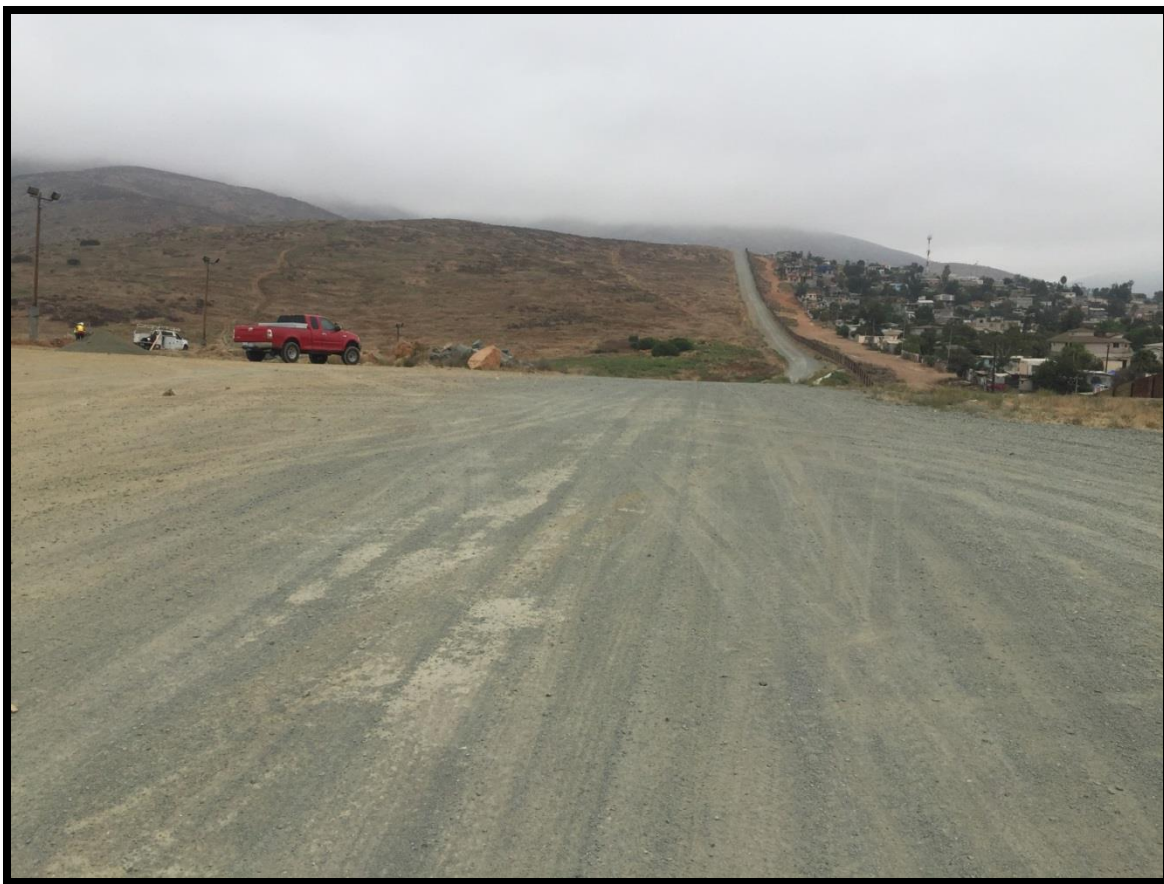
Photograph 12. This image depicts the typical level of disturbance and conditions within the prototype construction survey area (looking east from the eastern end of the secondary fence).
