Low-Cost Flood Sensors: Performance Analysis

A partnership between Charlotte-Mecklenburg Storm Water Services and the U.S. Department of Homeland Security Science and Technology Directorate

May 2020

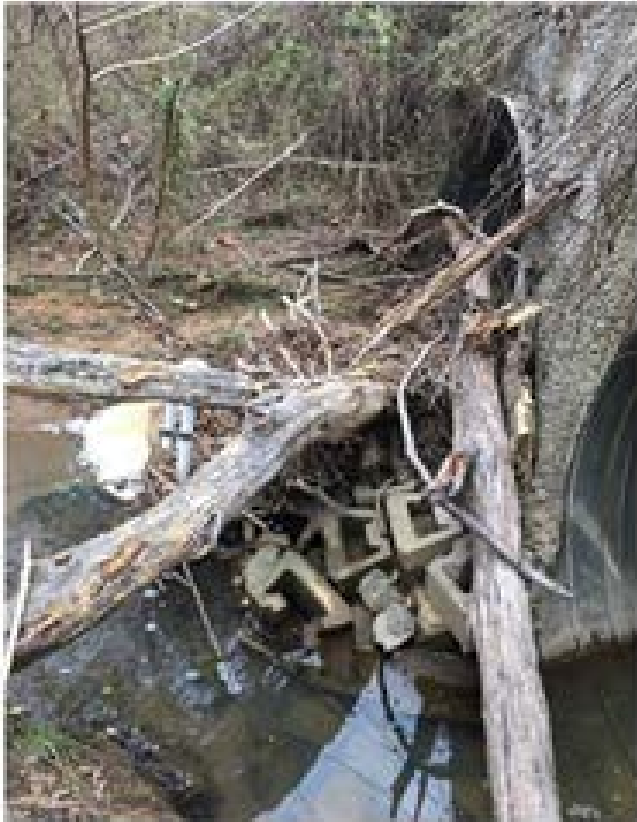
Photo of Storm debris blockage

- All vendors performed firmware updates
- Removing debris
- Replacing damaged items
 - Lower sensors
 - Solar panels
 - Antennas
- Validation measurements
