Low-Cost Flood Sensors: Performance Analysis

A partnership between Charlotte-Mecklenburg Storm Water Services and the U.S. Department of Homeland Security Science and Technology Directorate

May 2020

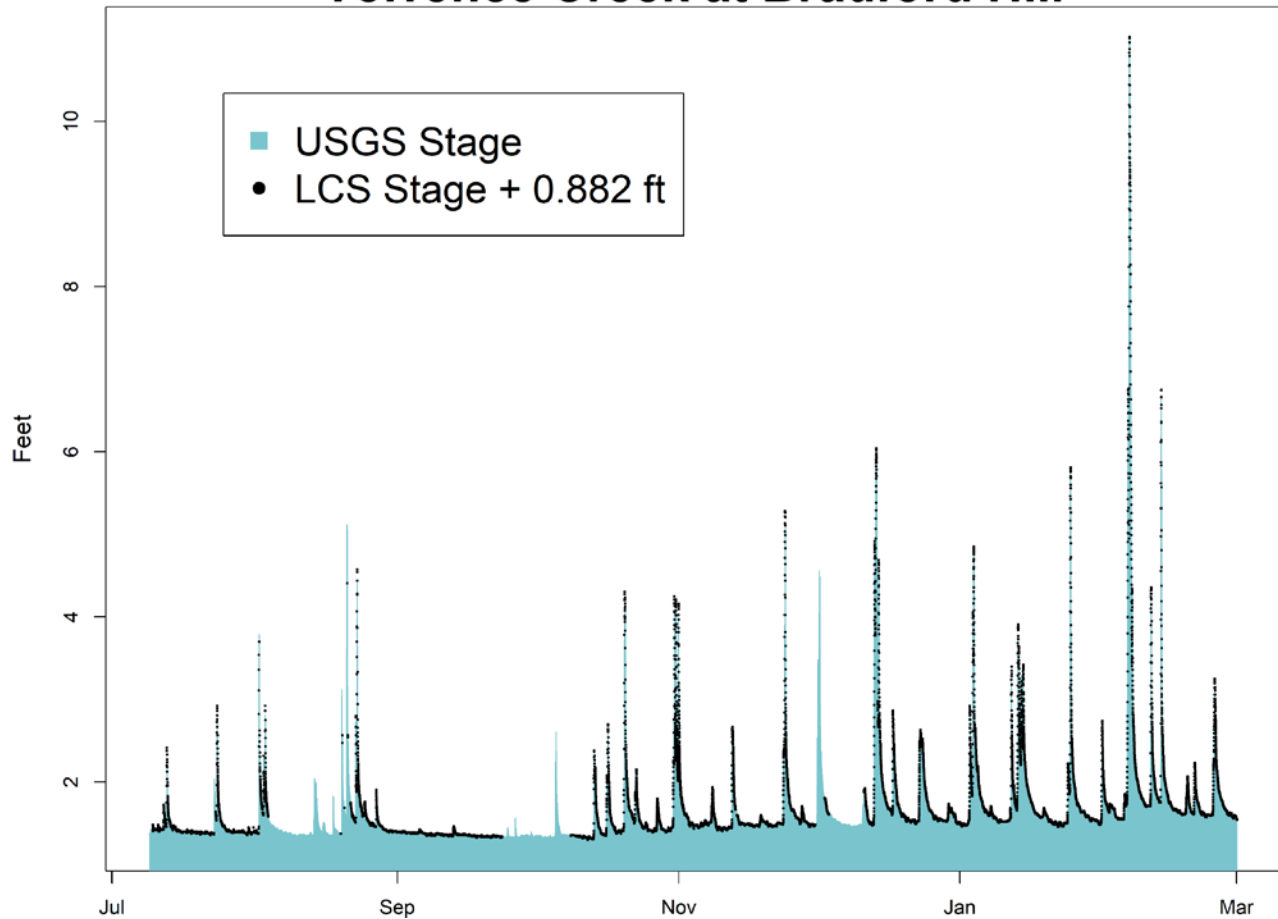
Figure 10: Comparison of USGS stage gauge 0214265808 and FMB7 for Torrence Creek at Bradford Hill Lane from July 8, 2019 to February 29, 2020

- The other five co-existing locations could not be correlated with the USGS equipment due to different hydraulic dynamics of the creeks. The LCS at FMB7 is the only site where the equipment was installed within $3'$ of the USGS equipment. Some sites were as far apart as $100'$ from the USGS equipment, opposite sides of the creek, in different pools or have supplemental flow entering between the two pieces of equipment. These factors can contribute to slightly different stages being recorded and direct comparisons could not be made. However, it should be noted that hydrographs prepared from LCS data tracked nearly the same as the USGS generated data.

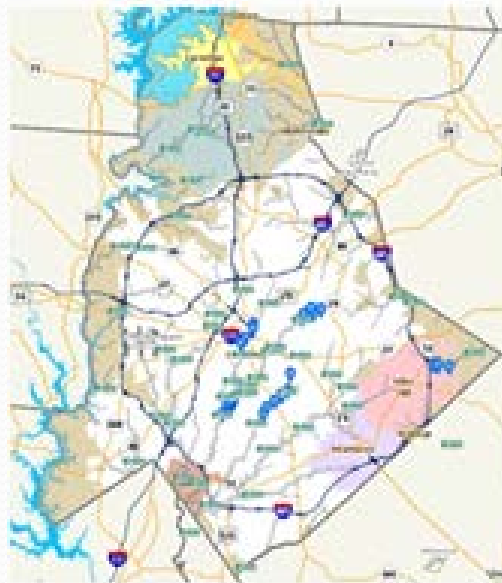
Base Year 1 :
50 USGS Gauges +
25 Alpha Sensor Sites =
51.2% of Flood Risk Monitored

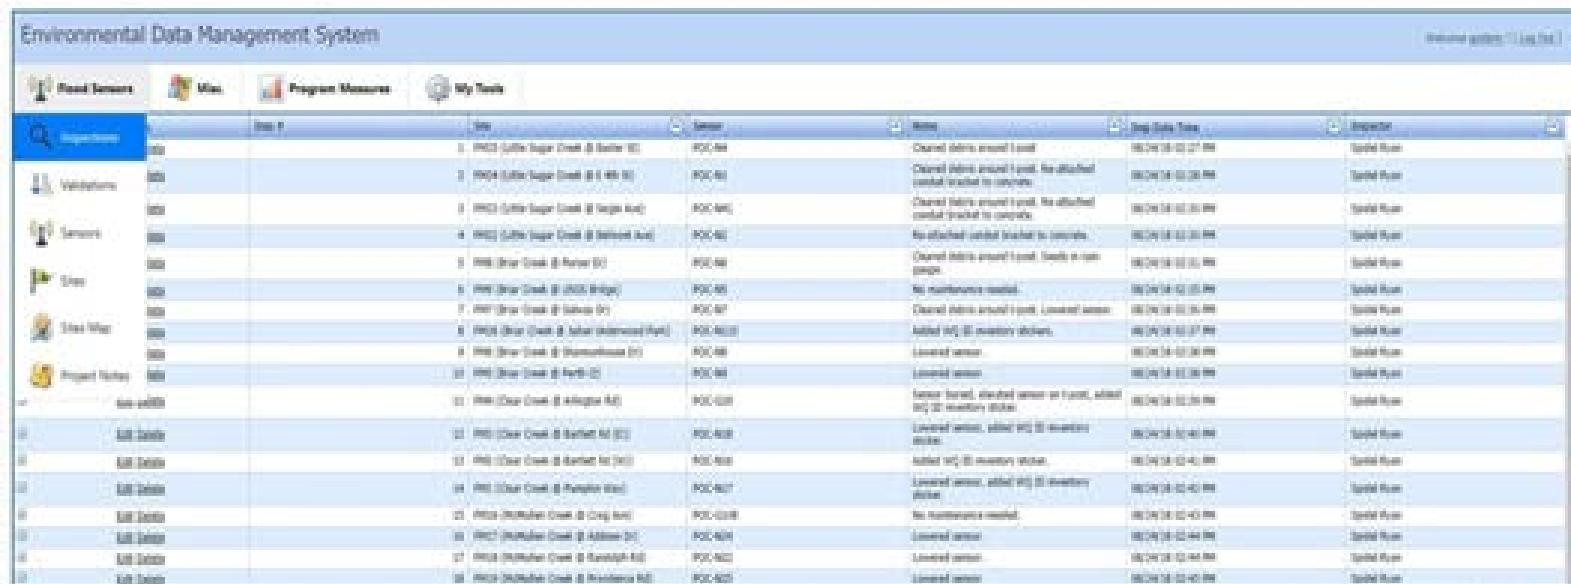
Operation and maintenance activities along with inspection information for the LCS was stored in a new module added to an existing database.

The screenshot displays the 'Environmental Data Management System' interface. It features a navigation menu on the left with icons for Road Sensors, Maps, Program Measures, and My Tools. The main area shows a table with columns for Inspection ID, Date, Site, Sensor, Notes, and Inspector. The table lists 18 inspection records, each with a unique ID, a date, a site description, a sensor type, a note about the inspection, and the name of the inspector.

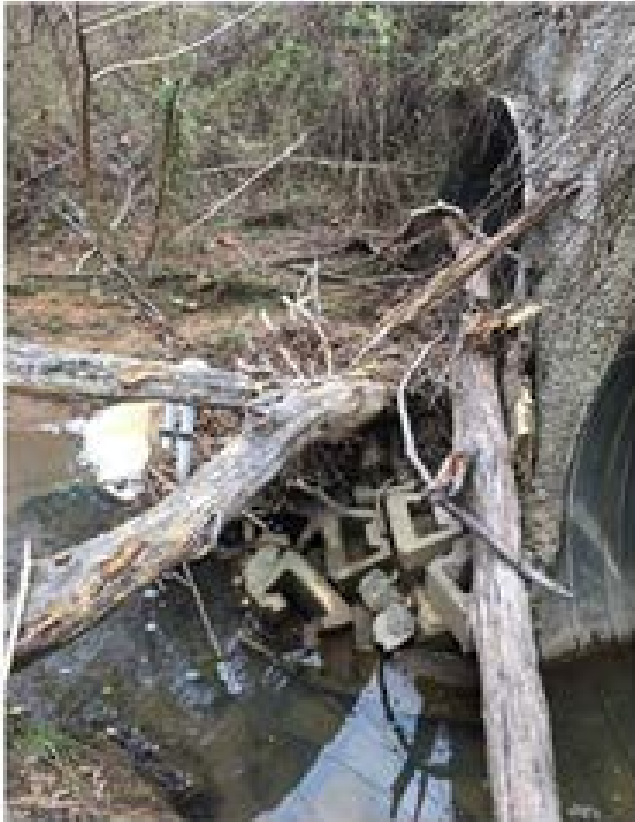
Photo of Storm debris blockage

- All vendors performed firmware updates
- Removing debris
- Replacing damaged items
 - Lower sensors
 - Solar panels
 - Antennas
- Validation measurements
