**Operational Field Assessment  
Post Assessment Report:**

**Emergency Medical Services Board Armor Backboard Cover**

Prepared in Support of the  
First Responder Technologies (R-Tech) Program  
Science and Technology Directorate  
US Department of Homeland Security

8 November 2011

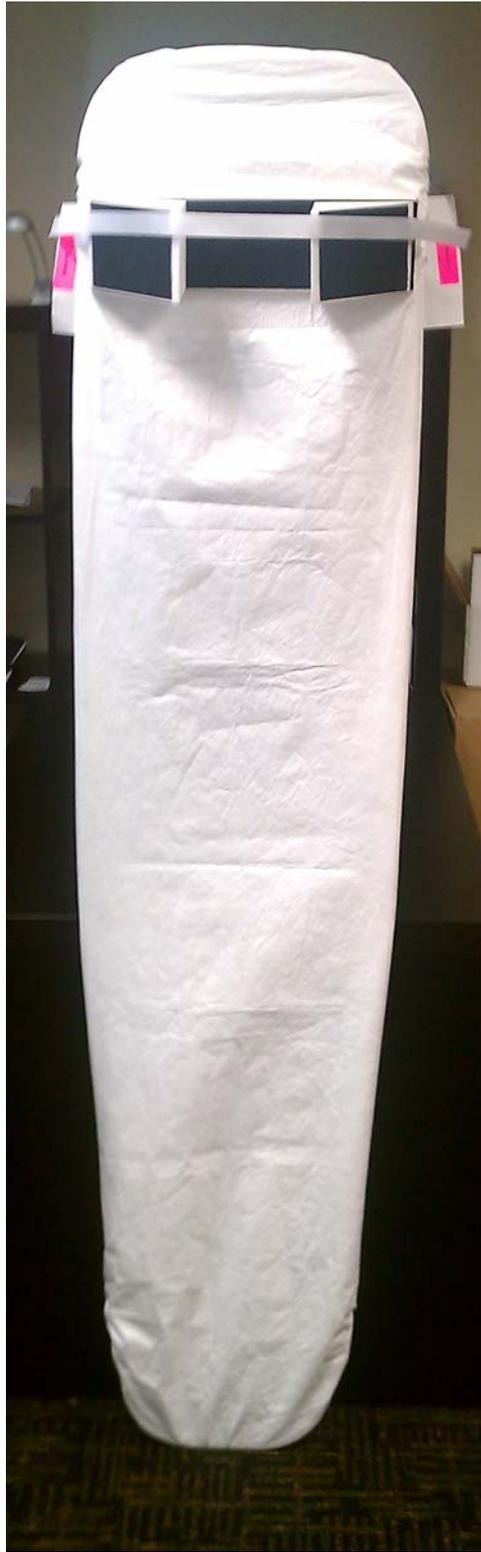
Figure 1. The Board Armor Backboard Cover with the integrated Cervical Immobilization Device (CID).

The material used to construct the backboard cover is Tyvek Tychem QC which is impermeable to fluids and has passed ASTM F1670 Synthetic blood penetration and ASTM F1671 Bacteriophage penetration tests. The material is white and will show staining in a way that may allow an emergency medical technician to distinguish the types of body fluid that are present. Three adhesive strips each measuring 6 inches by 13 inches are used to fix the cover to the backboard. The adhesive backing tabs are arranged such that they can be removed after the backboard cover has been attached to the backboard by using the elastic contained at the head and foot of the cover. The cover has a head and foot orientation and must be arranged correctly on the backboard. The foot of the cover is slightly tapered and the cervical immobilization device (CID) base is pre-attached at the head.

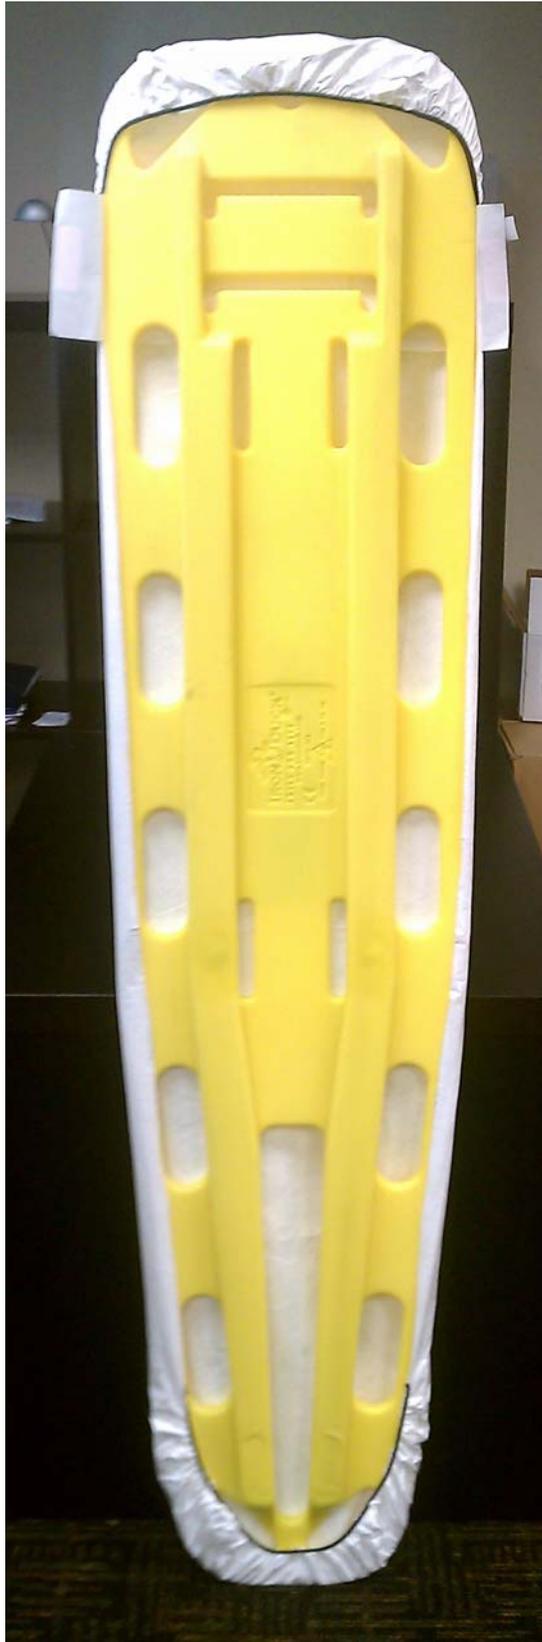
Figure 2. The Board Armor Backboard Cover from below.

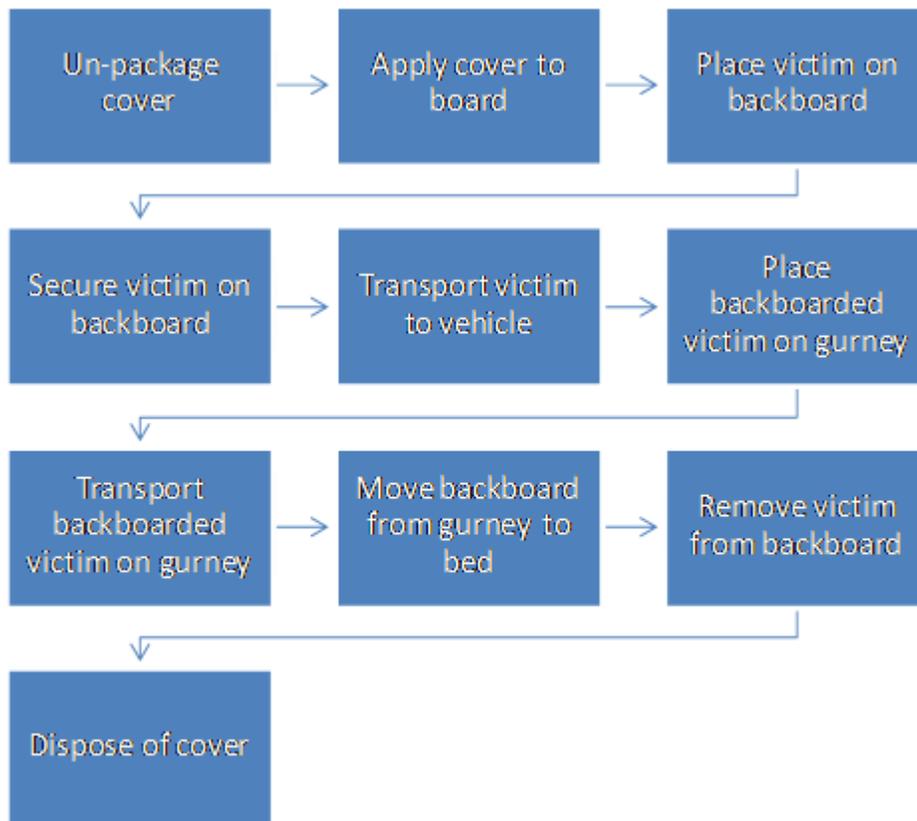
The backboard cover is packaged in a small plastic pouch that can be easily stored in an emergency medical services vehicle. After un-packaging, the backboard cover is placed on the backboard using the elastic located at the end of the cover, and then secured to the backboard with the adhesive tabs located on the back of the cover. This is achieved by pulling on tabs which extend out from the sides of the cover. Next, the emergency medical service providers place the victim on the backboard as they normally would and then apply the CID. Once the victim is secured and strapped to the backboard, the emergency medical service provider can transport the victim. Once the victim has been transferred from the backboard to a gurney, hospital bed, or other surface, the cover is removed from the backboard for disposal. When removing the cover from the backboard, it may be folded into its center from the outside edges to prevent spillage of accumulated bodily fluids and other matter. The cover and the integrated CID are disposed of in biohazard disposal containers at the location where the victim is transported. Figure below outlines the procedure for using the Board Armor Backboard Cover.

Figure 3. Diagram of the Board Armor Backboard Cover system usage.

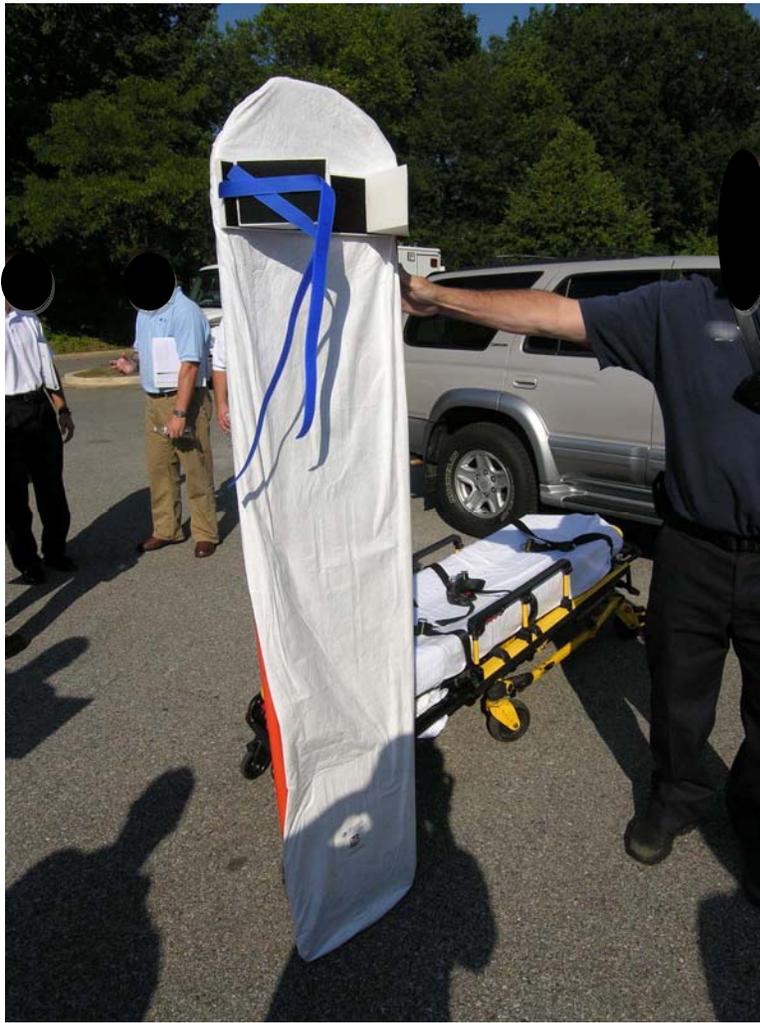
Figure 16. Inspection of the covered backboard after completion of Scenario 1. No damage was observed.

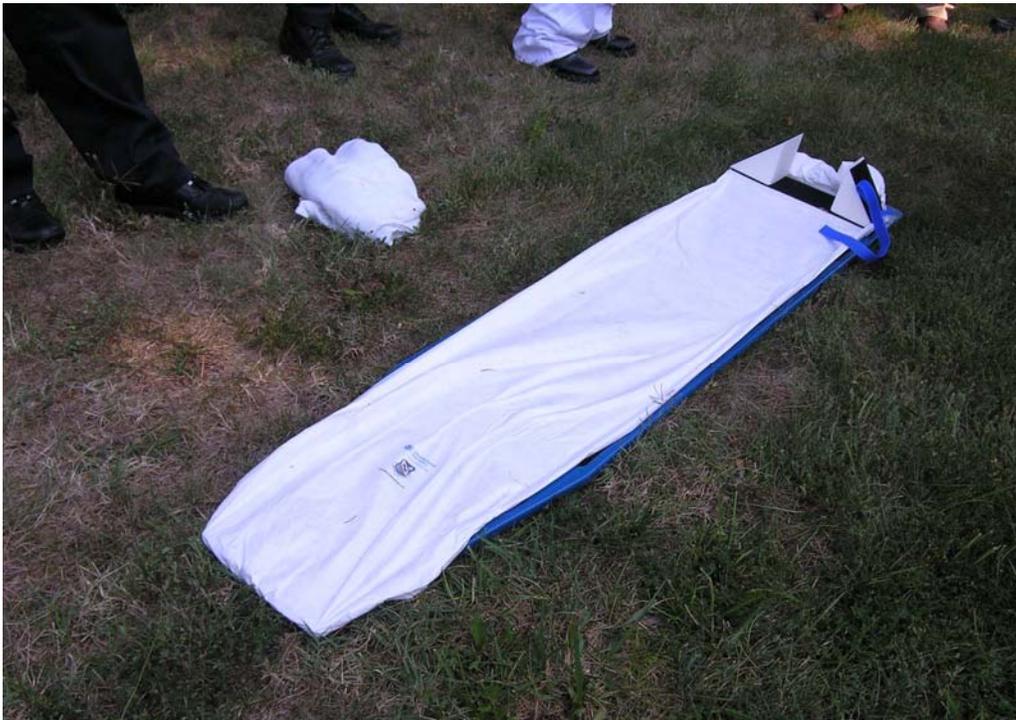
Figure 19. Inspection of the covered backboard after completion of Scenario 2a. No damage was observed.

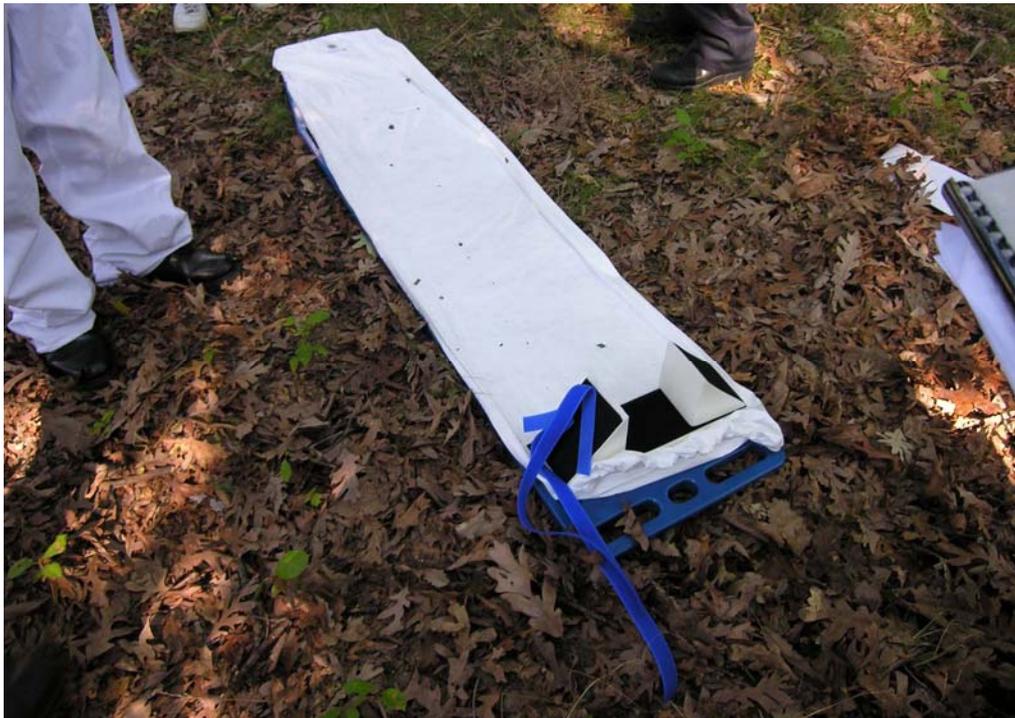
Figure 21. Inspection of the covered backboard after completion of Scenario 2b. No damage was found

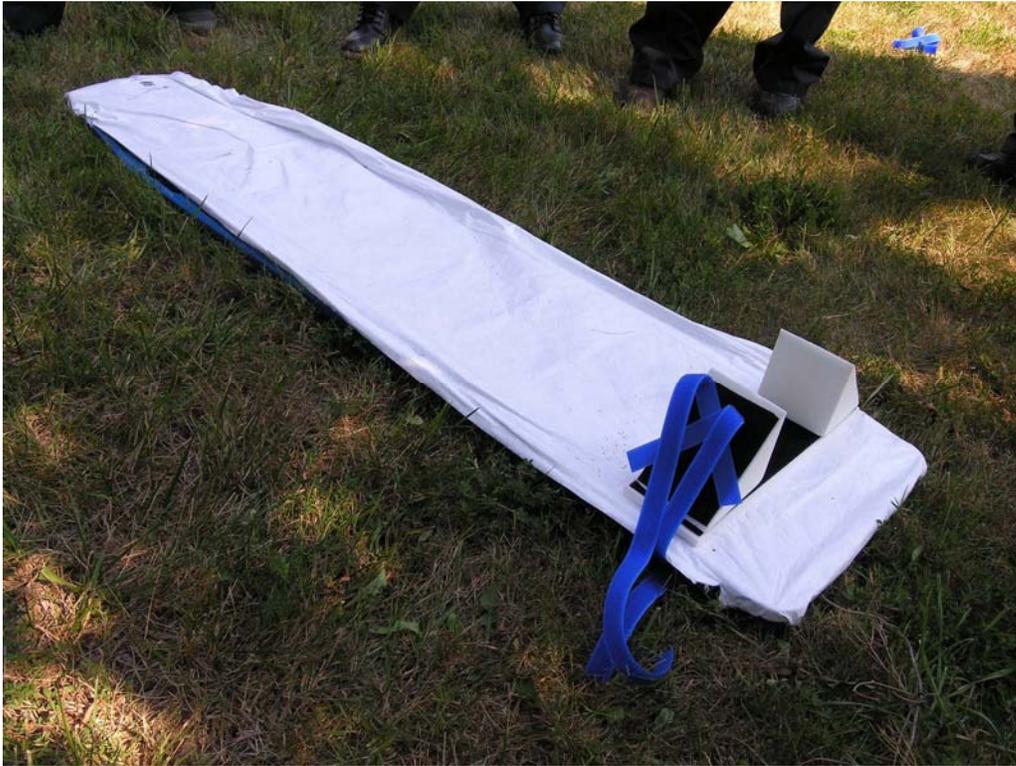
Figure 23. Inspection of the covered backboard after completion of Scenario 2c. No damage was observed.

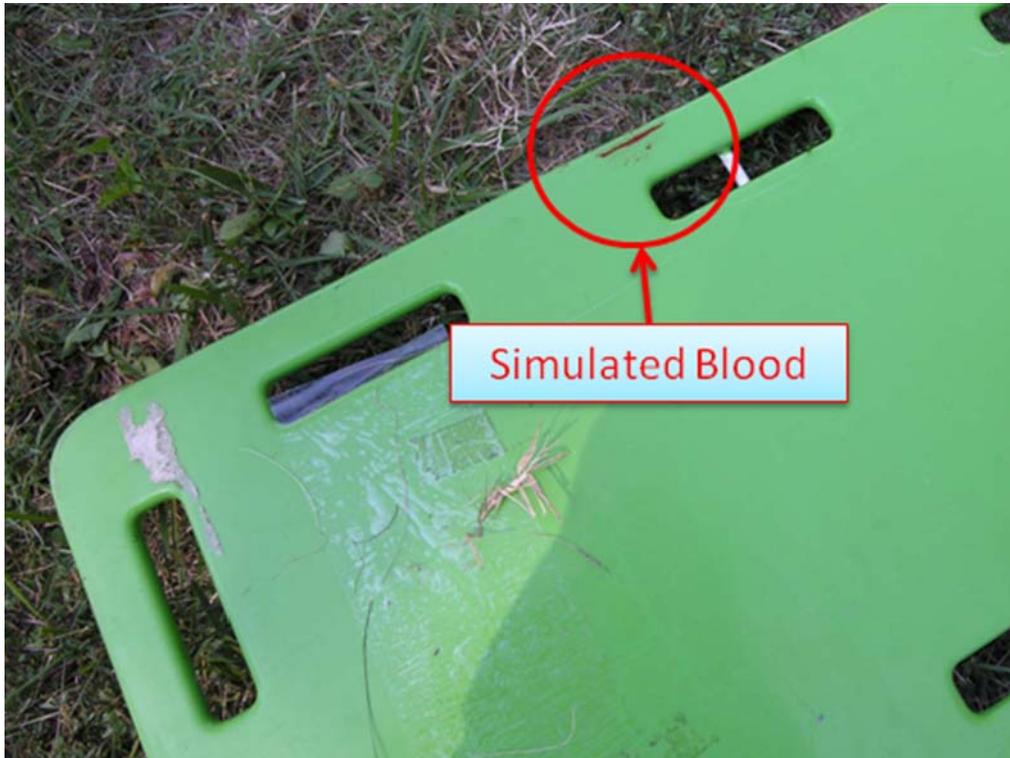
Figure 27. Inspection of the backboard after completion of Scenario 3a. A small amount of simulated blood was found on the edge of the backboard.

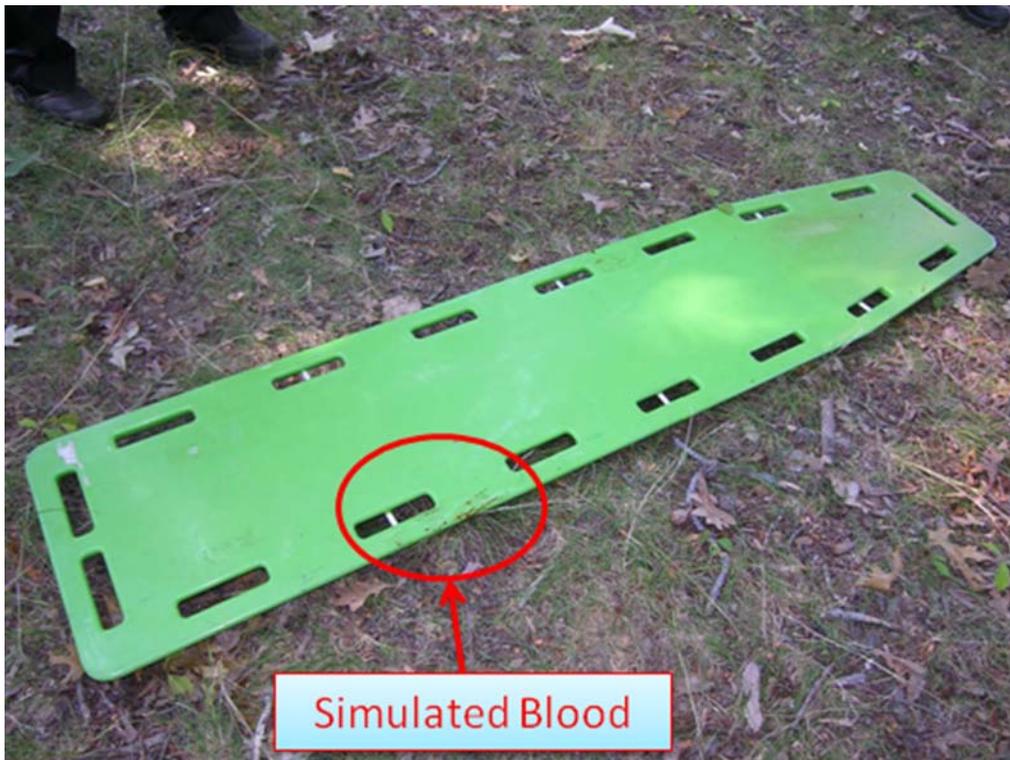
Figure 29. Inspection of backboard after completion of Scenario 3b. A small amount of simulated blood was found on the edge of the backboard.

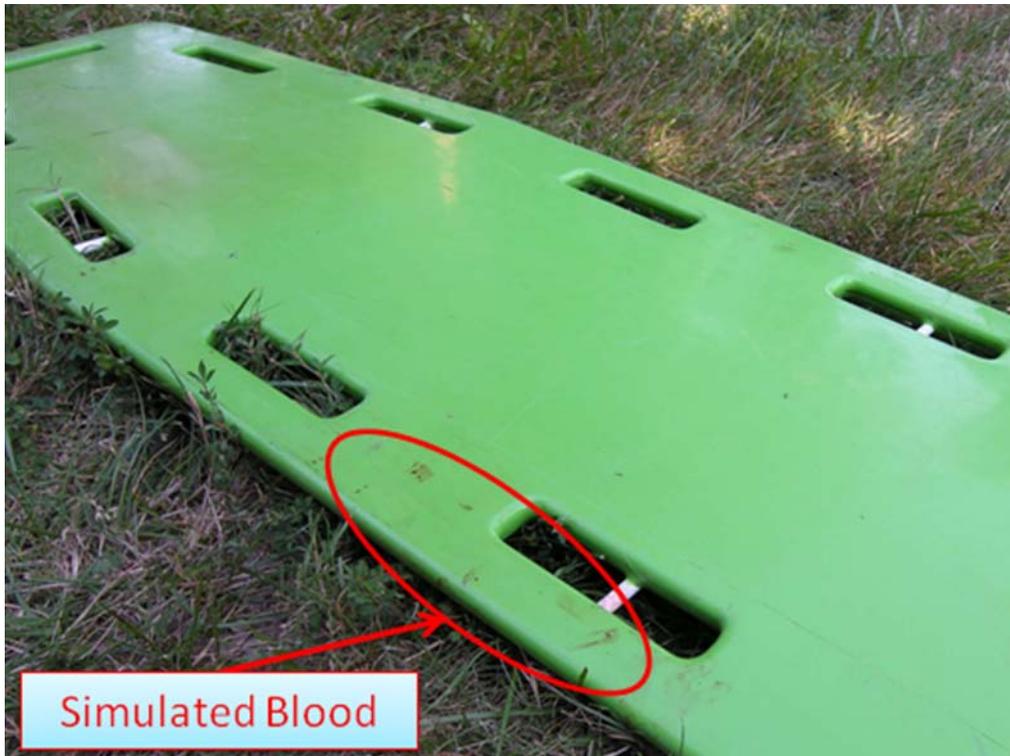
Figure 33. Inspection of the backboard after completion of Scenario 3c. A small amount of simulated blood was found on the edge of the backboard.

- The victim felt he was sliding a bit back and forth on the backboard while being transported. The amount of movement was the same as being transported on the backboard without a cover
- There was some minor amount of simulated blood found on the front edge of the backboard

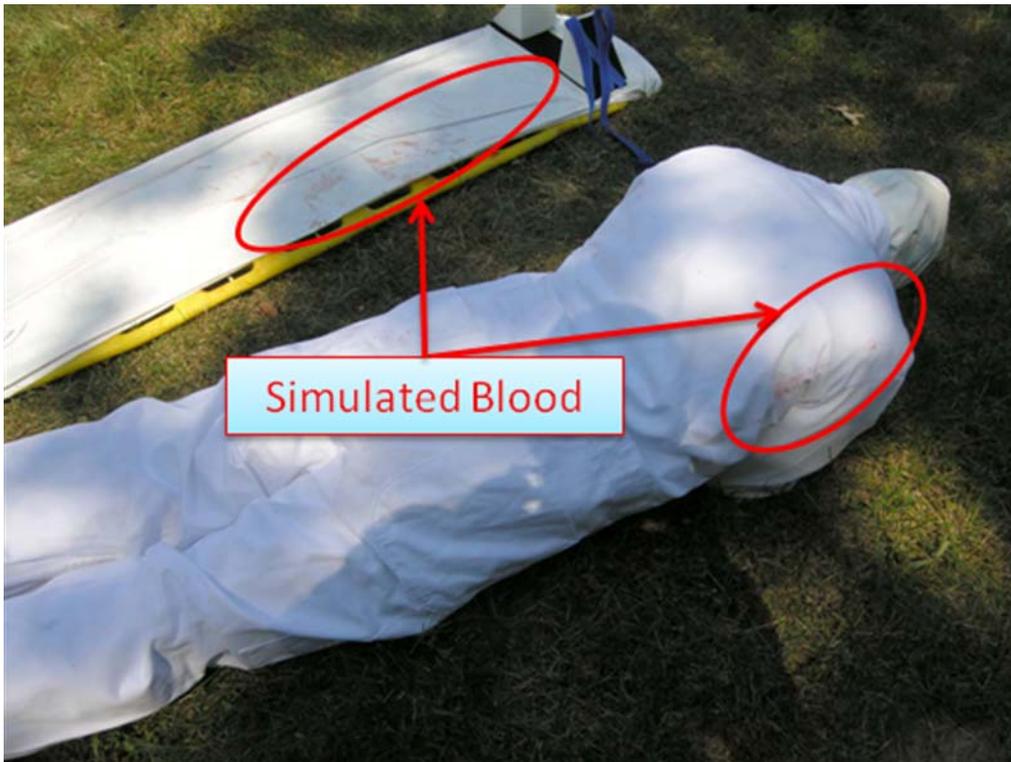
Figure 35. Inspection of the victim's back and the covered backboard after completion of Scenario 4aa. A small amount of simulated blood was found on the cover and the victim's shoulder.

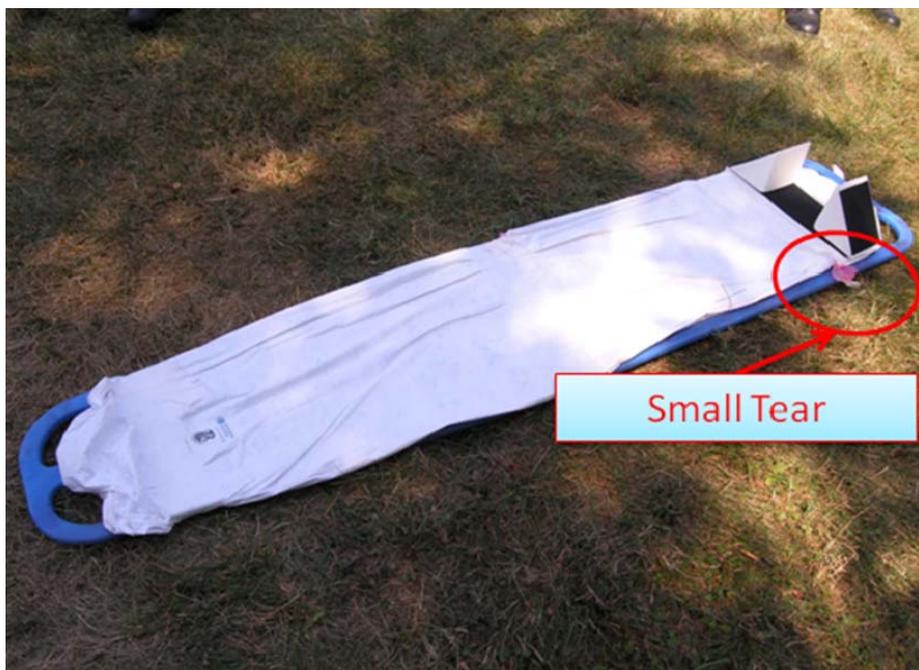
- The Board Armor Backboard Cover was easy to deploy, and robust enough to deal with a full range of environments and the elements.
  - There was one minor tear in the Board Armor Backboard Cover near the elastic cuff, but the tear was local and did not affect the covers performance.

- The Board Armor Backboard Cover is designed to be a one-time use item, and the minor tear that occurred by the elastic cuff did not compromise the integrity of the barrier device.

Figure 38. Inspection of the covered backboard after Scenario 4ab. A small tear was observed on the cover.

- The victim could not tell the difference from a standard uncovered backboard and a covered backboard while being transported
- There was small amount of simulated blood found on the victim's back
- There was a small tear found near the head area of the cover

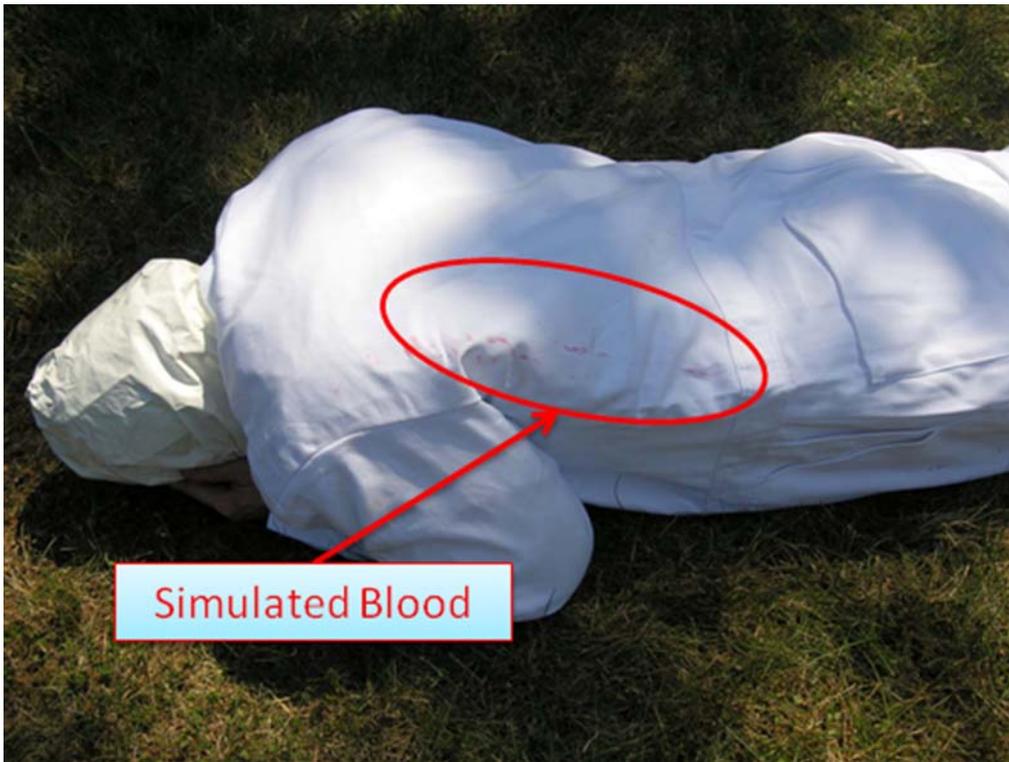
Figure 39. Inspection of the victim's back after Scenario 4ab. A small amount of simulated blood was found on the victim's back.

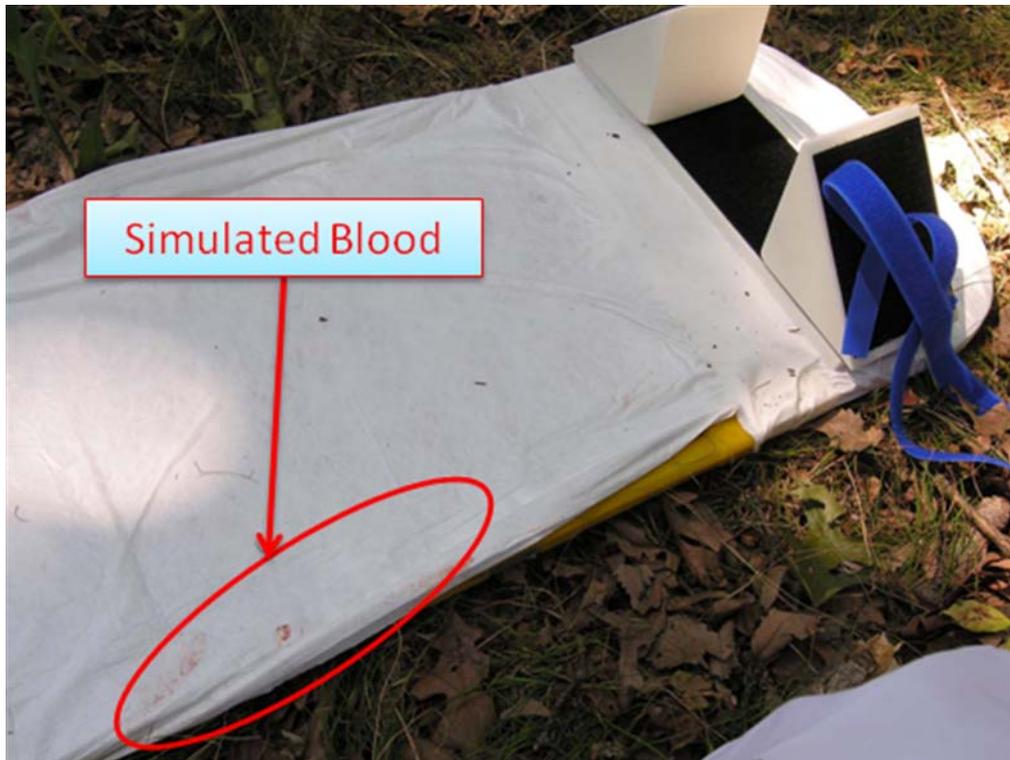
Figure 41. Inspection of the covered backboard after completion of Scenario 4ac. Minor simulated blood was found.

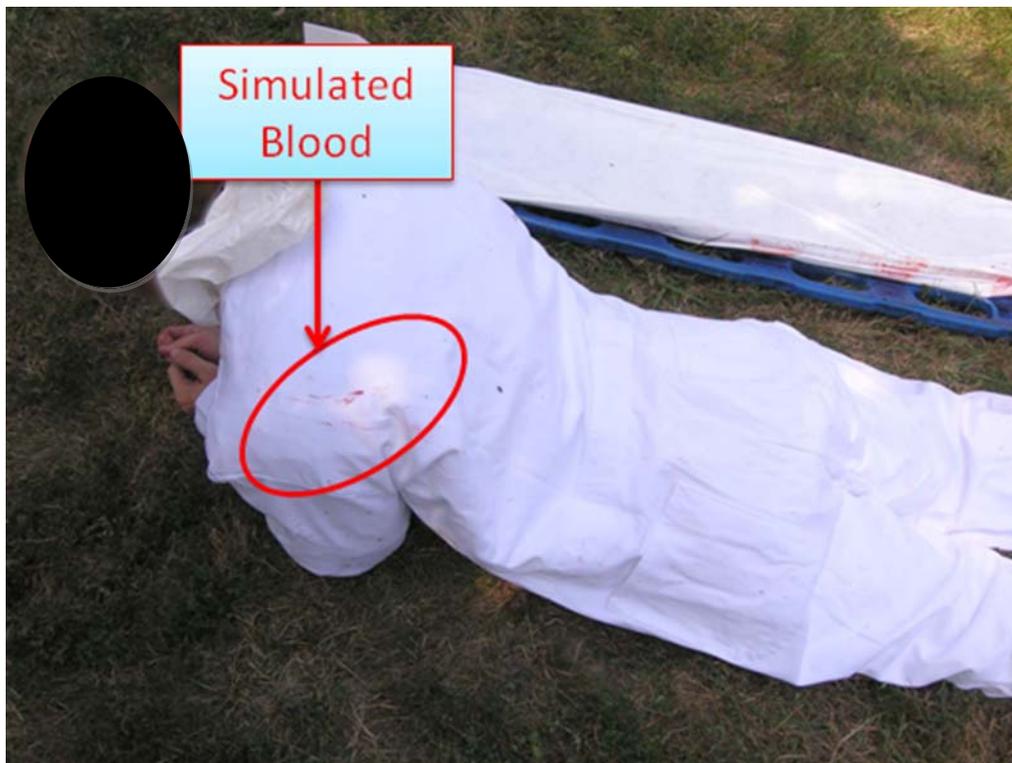
Figure 44. Inspection of the covered backboard and the victim's back after the completion of Scenario 4b. Minor simulated blood spot were found on the victim's shoulder.

- The adhesive was not as sticky, but it still held and worked well during the test
- There were no differences in applying the backboard cover to the new model backboard used during this test from the procedures used for the previous backboards
- The victim could not tell the difference from a standard uncovered backboard and a covered backboard while being transported.
- There was a small amount of simulated blood found on the victim's shoulder

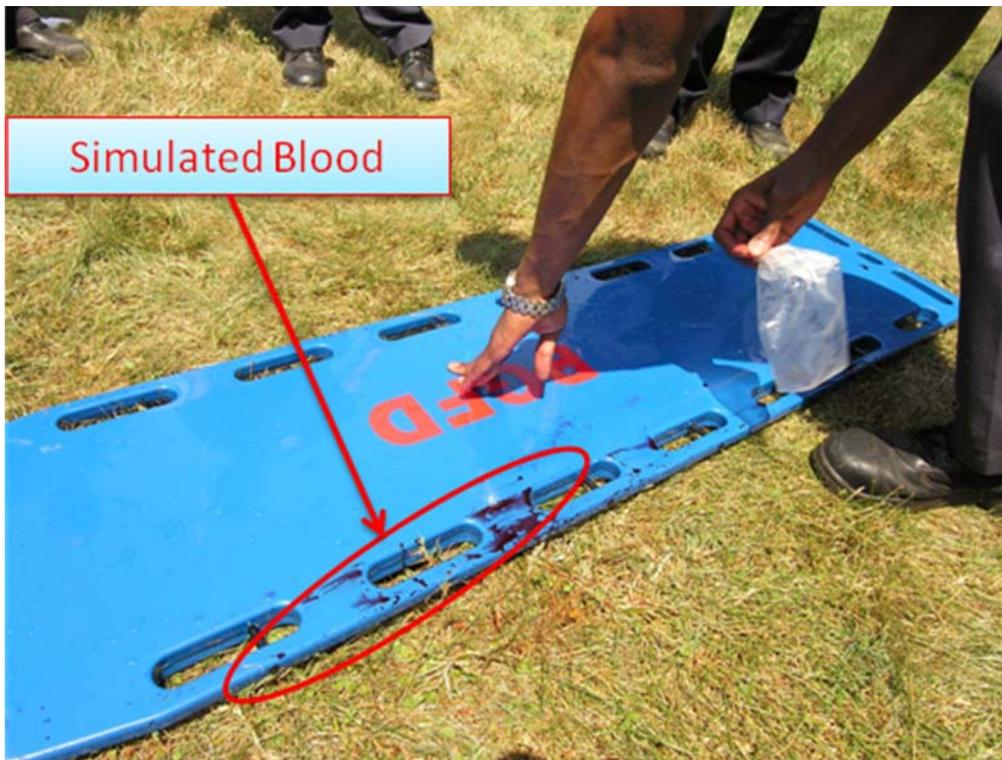
Figure 47. Inspection of the backboard after completion of Scenario 5a. A small amount of simulated blood was found at the edge of the backboard.

- There was no slippage while the victim was being transported
- There was a small amount of simulated blood found on the edge of the backboard

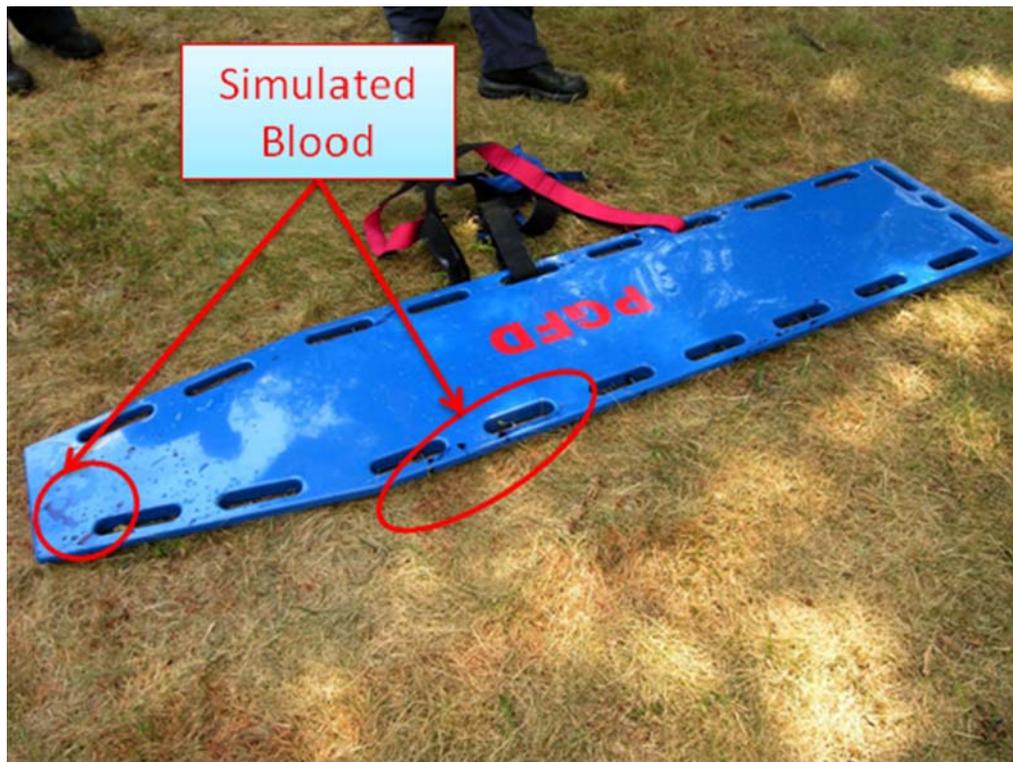
Figure 50. Inspection of the backboard after completion of Scenario 5b. A small amount of simulated blood was found on the edge of the backboard.

- There was no slippage while transporting the victim
- There was some simulated blood found at the edge of the backboard

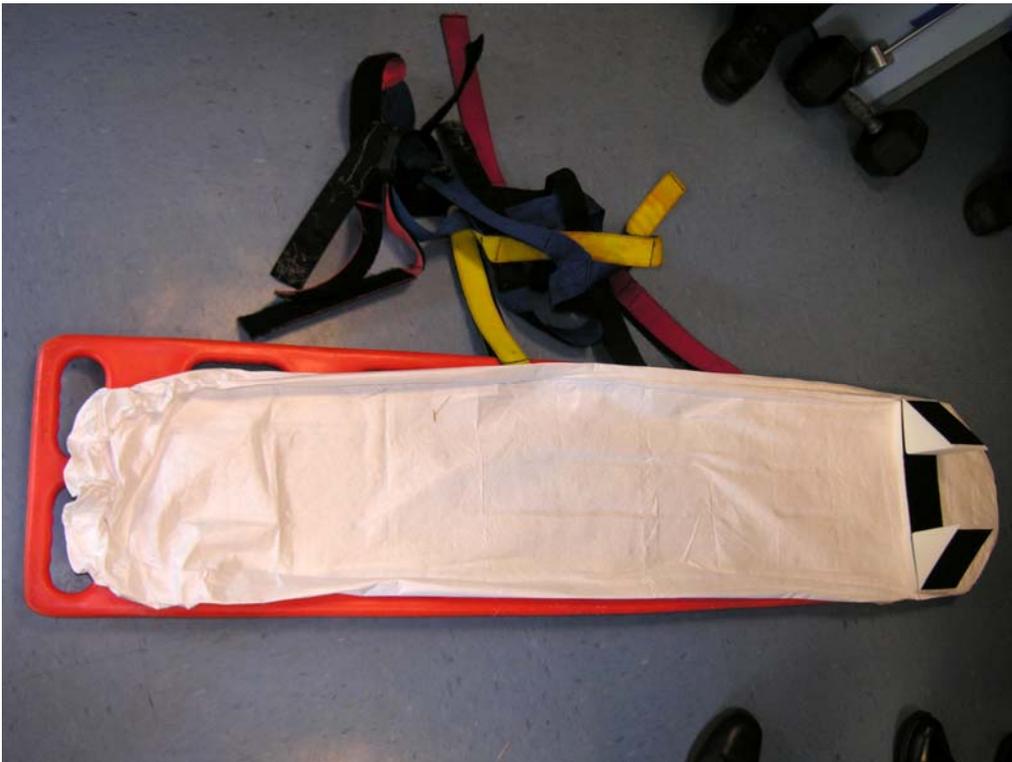
Figure 53. View of the backboard after the completion of Scenario 6. No damage was observed.

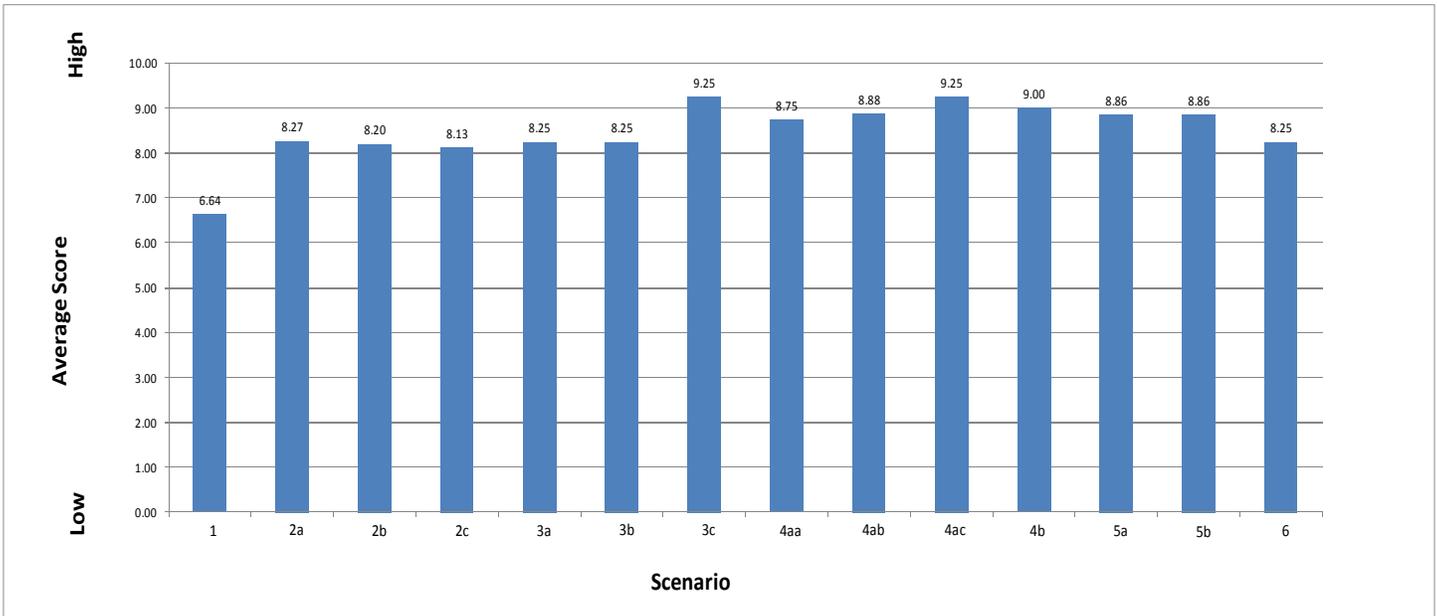
Figure 54. Average Score vs. Scenario Chart for the Function: Un-packaging and applying the backboard cover.
