**Operational Field Assessment  
Post Assessment Report:**

**Emergency Medical Services Board Armor Backboard Cover**

Prepared in Support of the  
First Responder Technologies (R-Tech) Program  
Science and Technology Directorate  
US Department of Homeland Security

8 November 2011

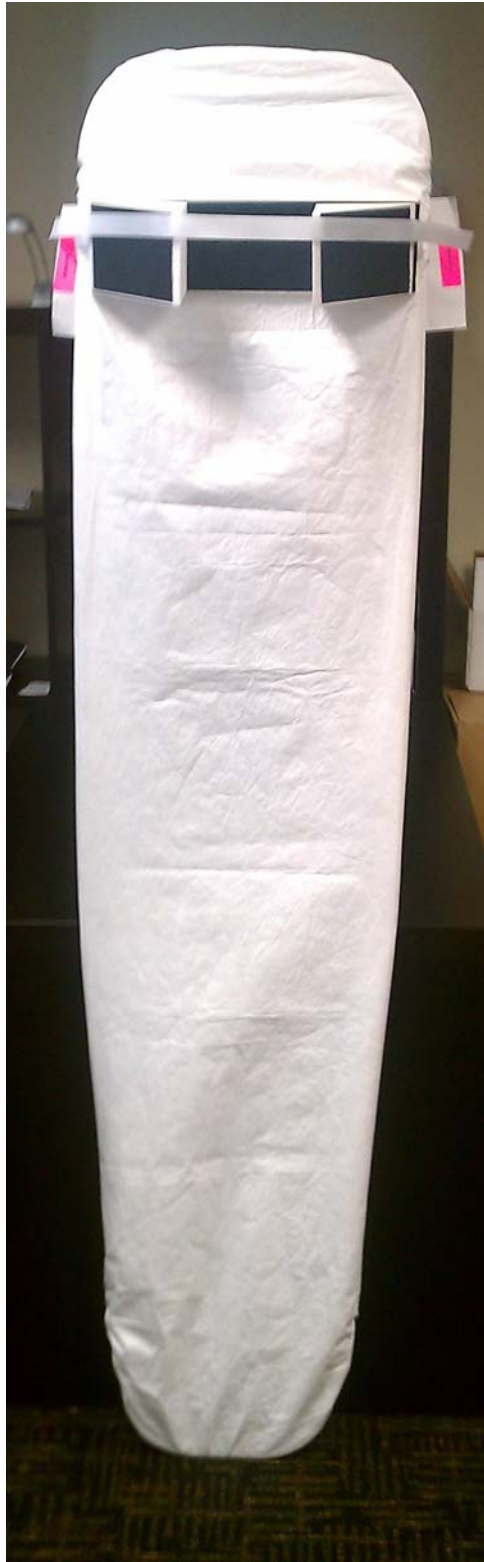
Figure 1. The Board Armor Backboard Cover with the integrated Cervical Immobilization Device (CID).

The material used to construct the backboard cover is Tyvek Tychem QC which is impermeable to fluids and has passed ASTM F1670 Synthetic blood penetration and ASTM F1671 Bacteriophage penetration tests. The material is white and will show staining in a way that may allow an emergency medical technician to distinguish the types of body fluid that are present. Three adhesive strips each measuring 6 inches by 13 inches are used to fix the cover to the backboard. The adhesive backing tabs are arranged such that they can be removed after the backboard cover has been attached to the backboard by using the elastic contained at the head and foot of the cover. The cover has a head and foot orientation and must be arranged correctly on the backboard. The foot of the cover is slightly tapered and the cervical immobilization device (CID) base is pre-attached at the head.

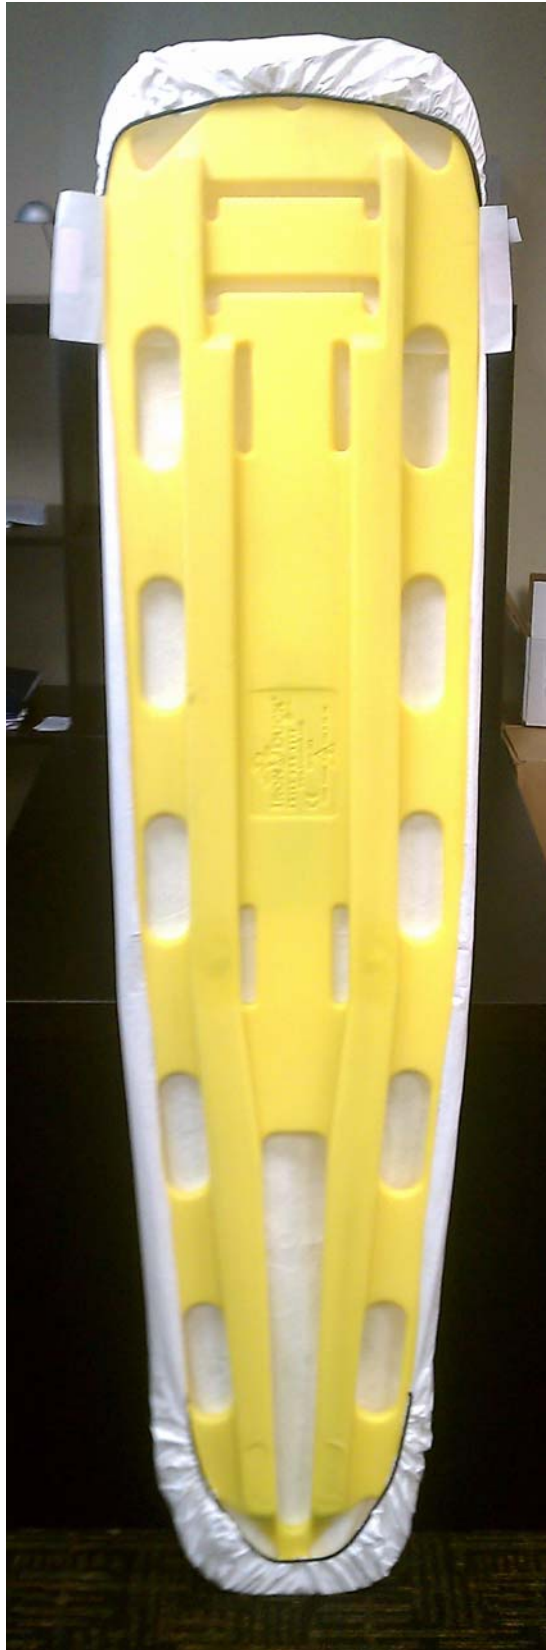
Figure 2. The Board Armor Backboard Cover from below.

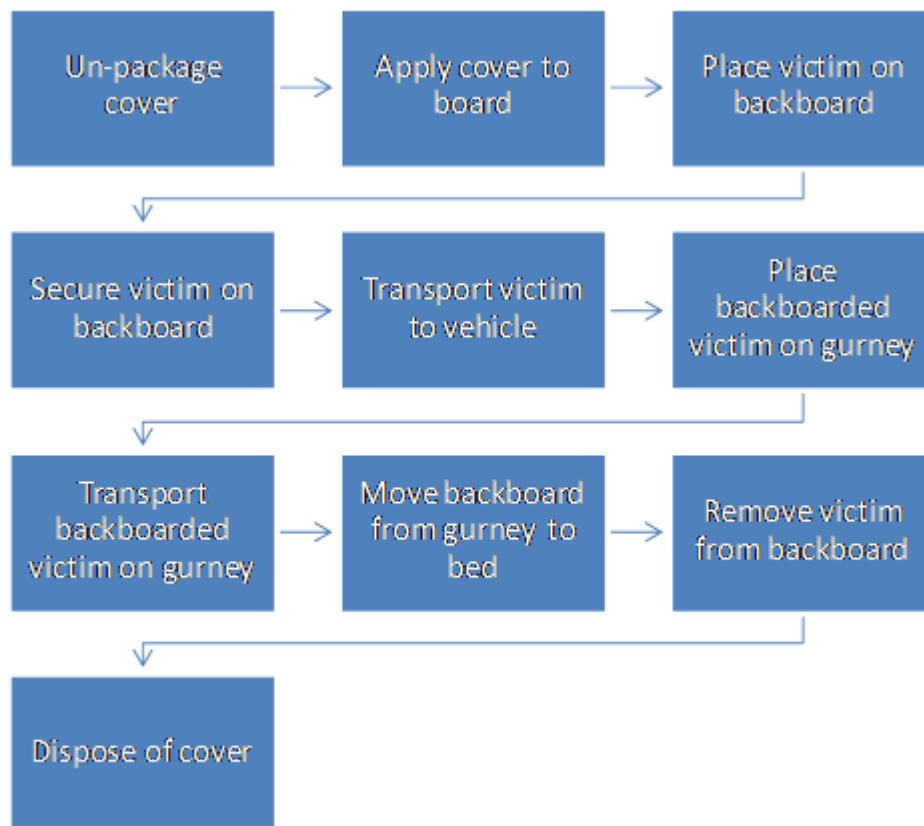
Figure 3. Diagram of the Board Armor Backboard Cover system usage.

The backboard cover is packaged in a small plastic pouch that can be easily stored in an emergency medical services vehicle. After un-packaging, the backboard cover is placed on the backboard using the elastic located at the end of the cover, and then secured to the backboard with the adhesive tabs located on the back of the cover. This is achieved by pulling on tabs which extend out from the sides of the cover. Next, the emergency medical service providers place the victim on the backboard as they normally would and then apply the CID. Once the victim is secured and strapped to the backboard, the emergency medical service provider can transport the victim. Once the victim has been transferred from the backboard to a gurney, hospital bed, or other surface, the cover is removed from the backboard for disposal. When removing the cover from the backboard, it may be folded into its center from the outside edges to prevent spillage of accumulated bodily fluids and other matter. The cover and the integrated CID are disposed of in biohazard disposal containers at the location where the victim is transported. Figure below outlines the procedure for using the Board Armor Backboard Cover.

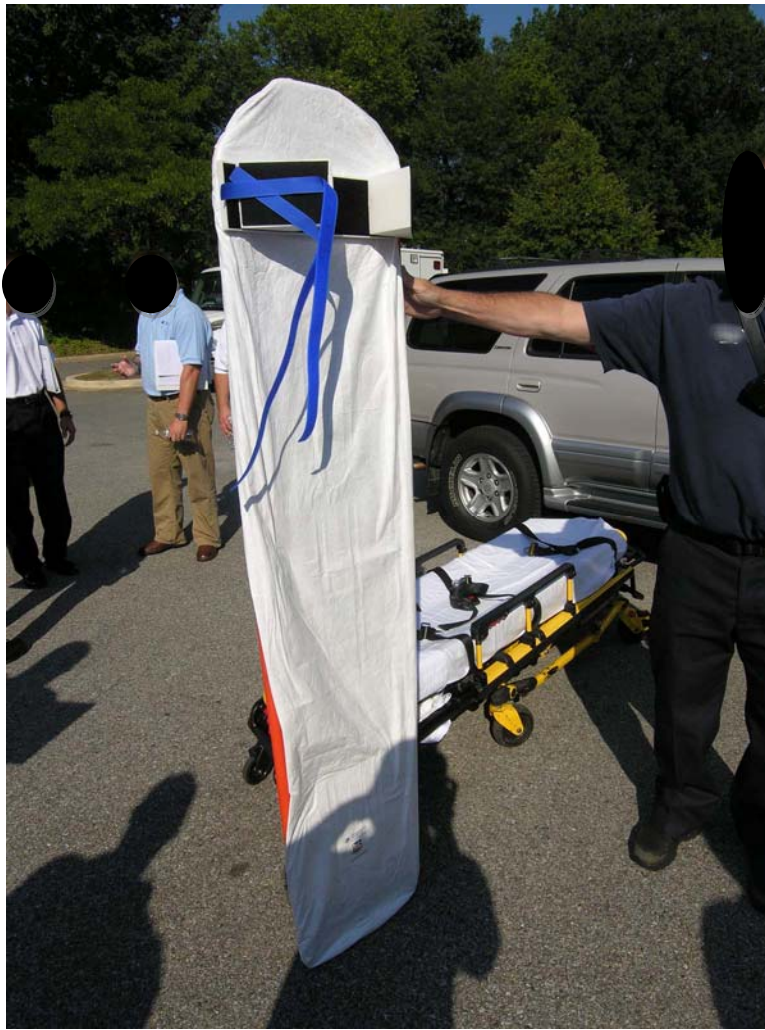
Figure 16. Inspection of the covered backboard after completion of Scenario 1. No damage was observed.

- The package was difficult to open
- A lot of plastic/paper trash would be left behind the scene after un-packaging
- Recommended storing the CID straps and CID blocks in the same package
- The victim felt very secure, could not tell the difference from a standard uncovered backboard

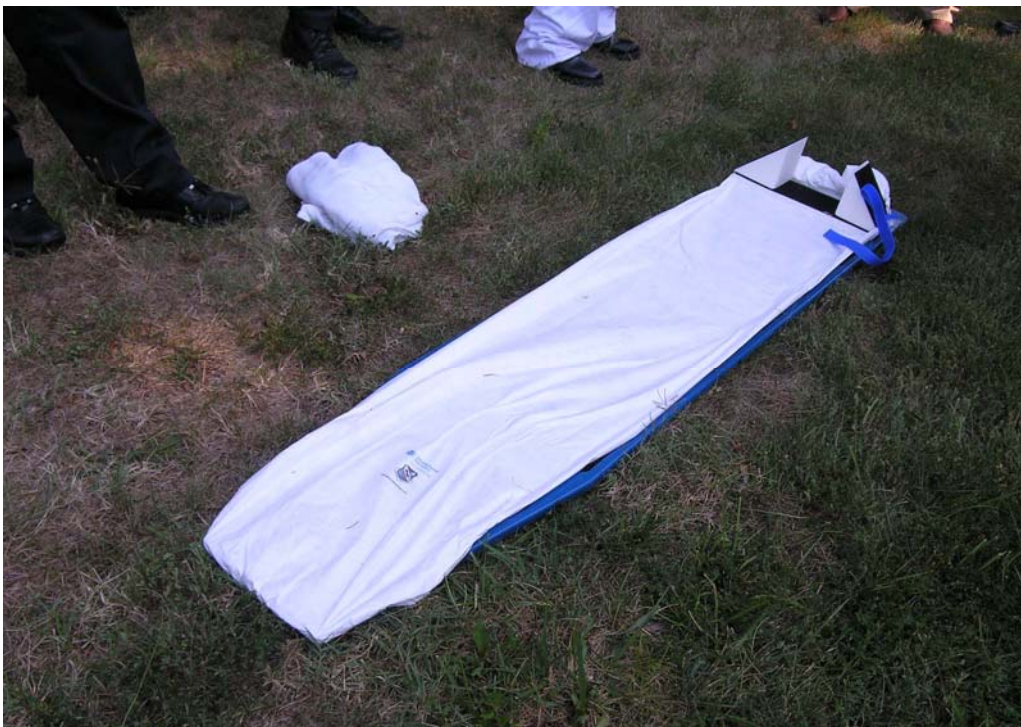
Figure 19. Inspection of the covered backboard after completion of Scenario 2a. No damage was observed.

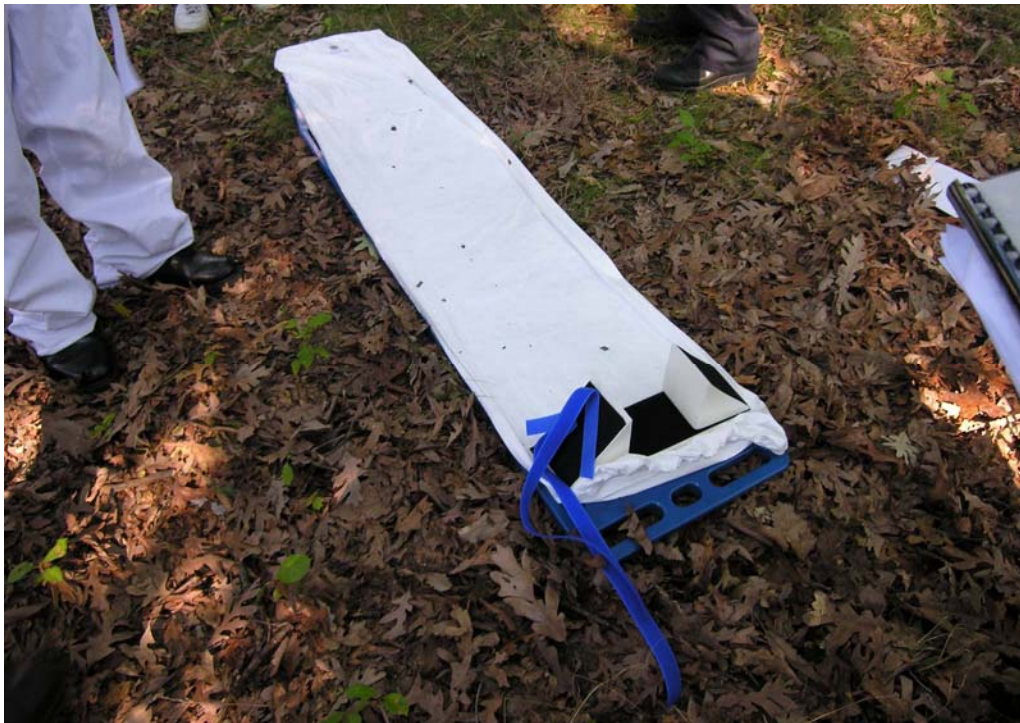
Figure 21. Inspection of the covered backboard after completion of Scenario 2b. No damage was found

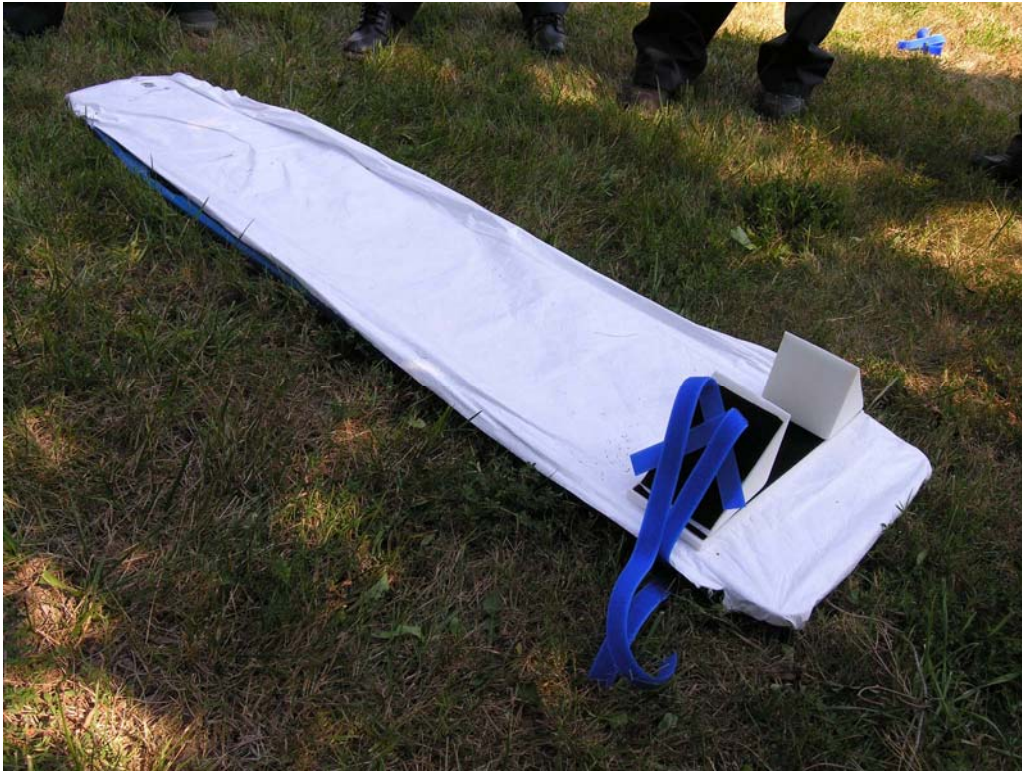
Figure 23. Inspection of the covered backboard after completion of Scenario 2c. No damage was observed.

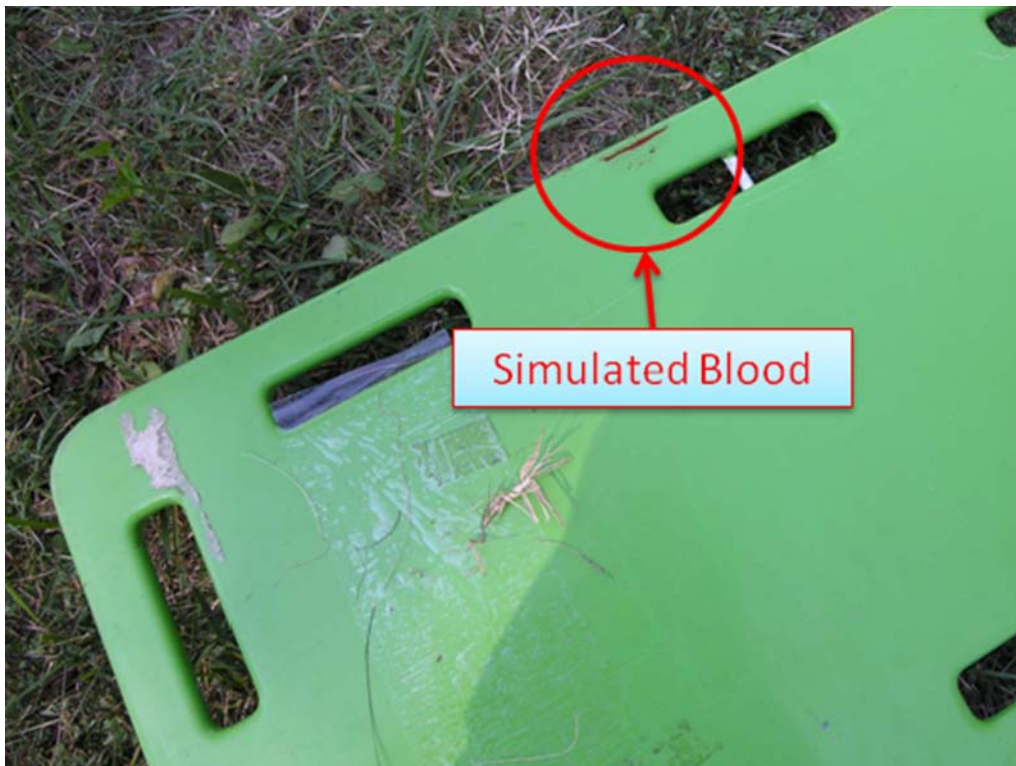
Figure 27. Inspection of the backboard after completion of Scenario 3a. A small amount of simulated blood was found on the edge of the backboard.

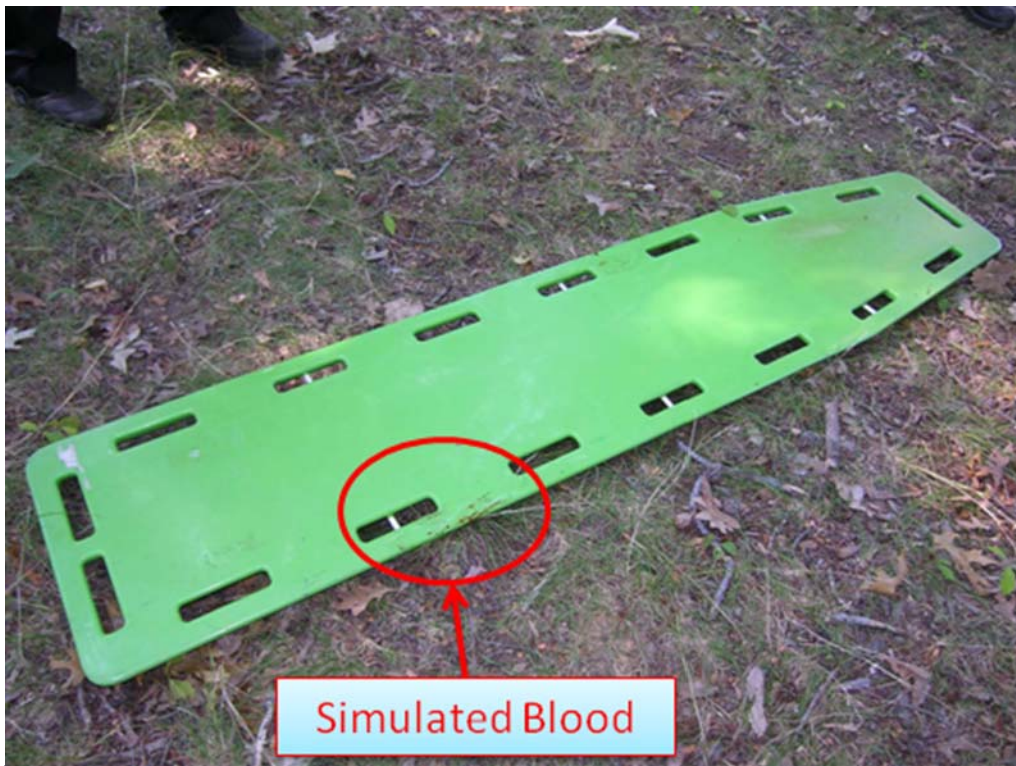
Figure 29. Inspection of backboard after completion of Scenario 3b. A small amount of simulated blood was found on the edge of the backboard.

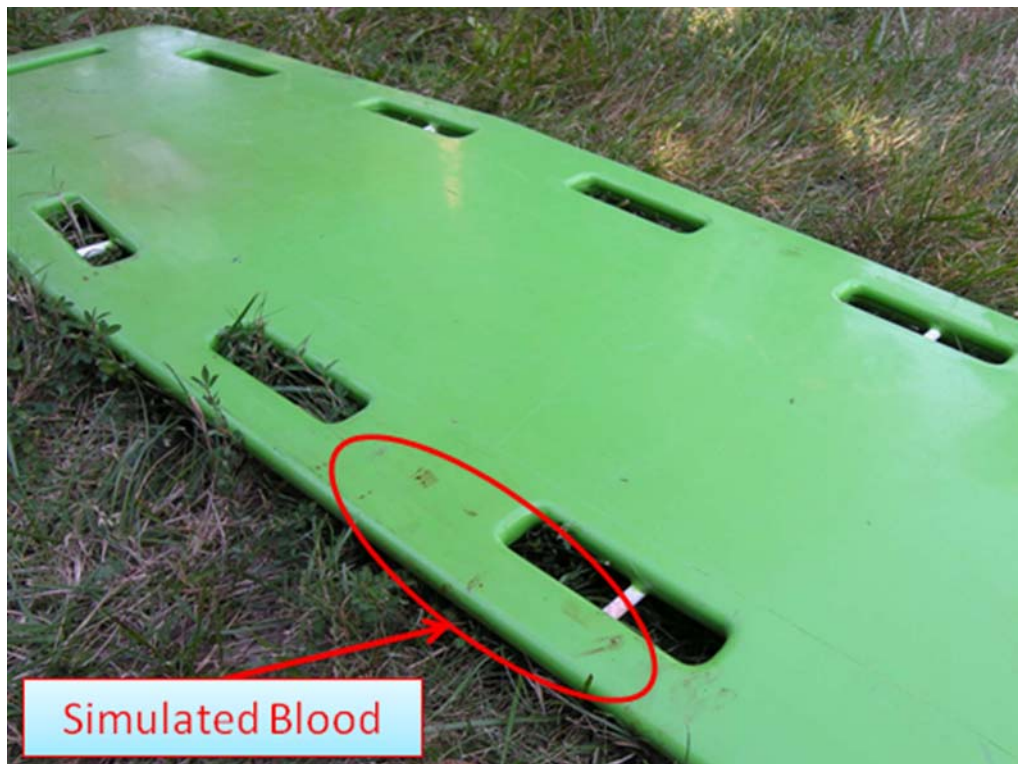
Figure 33. Inspection of the backboard after completion of Scenario 3c. A small amount of simulated blood was found on the edge of the backboard.

- The victim felt he was sliding a bit back and forth on the backboard while being transported. The amount of movement was the same as being transported on the backboard without a cover
- There was some minor amount of simulated blood found on the front edge of the backboard

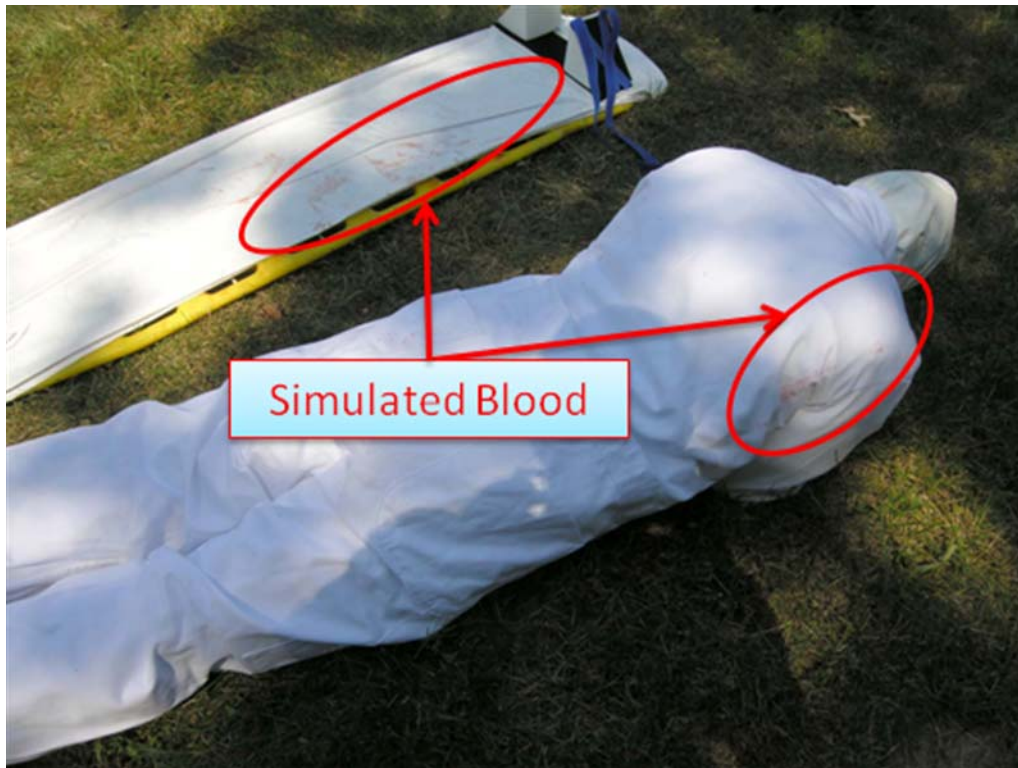
Figure 35. Inspection of the victim's back and the covered backboard after completion of Scenario 4aa. A small amount of simulated blood was found on the cover and the victim's shoulder.

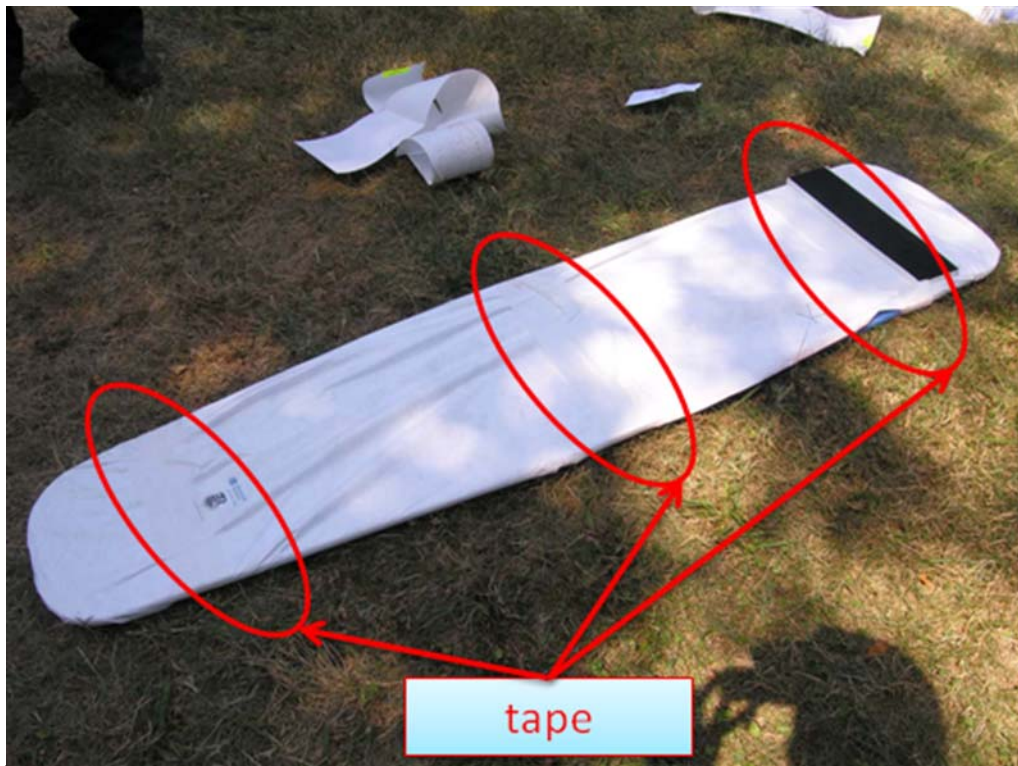
Figure 37. The covered backboard was taped before transporting the victim. The cover worked well with the tape. (Scenario 4ab)

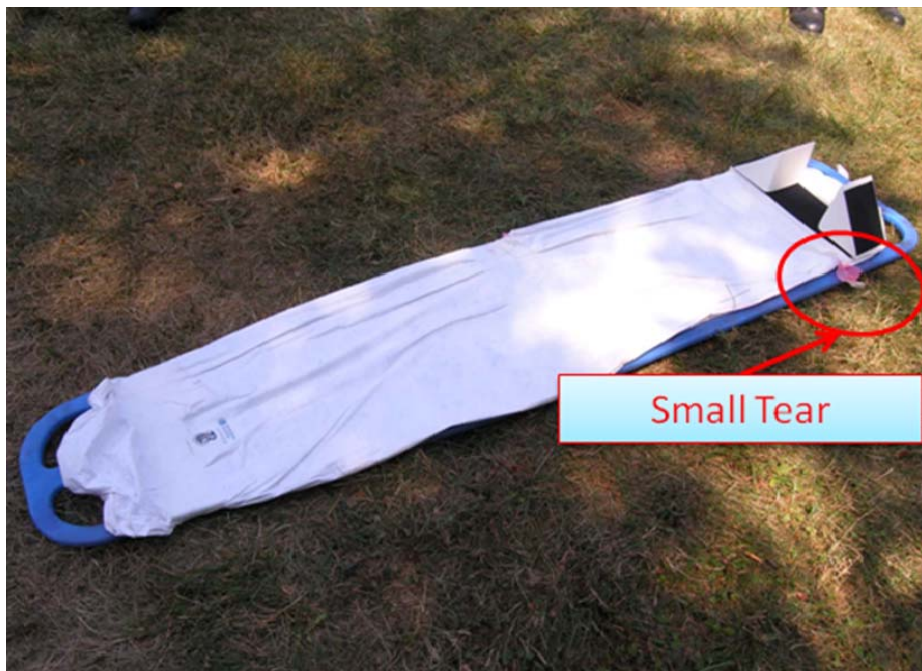
Figure 38. Inspection of the covered backboard after Scenario 4ab. A small tear was observed on the cover.

- The Board Armor Backboard Cover was easy to deploy, and robust enough to deal with a full range of environments and the elements.
  - There was one minor tear in the Board Armor Backboard Cover near the elastic cuff, but the tear was local and did not affect the covers performance.

- The victim could not tell the difference from a standard uncovered backboard and a covered backboard while being transported
- There was small amount of simulated blood found on the victim's back
- There was a small tear found near the head area of the cover

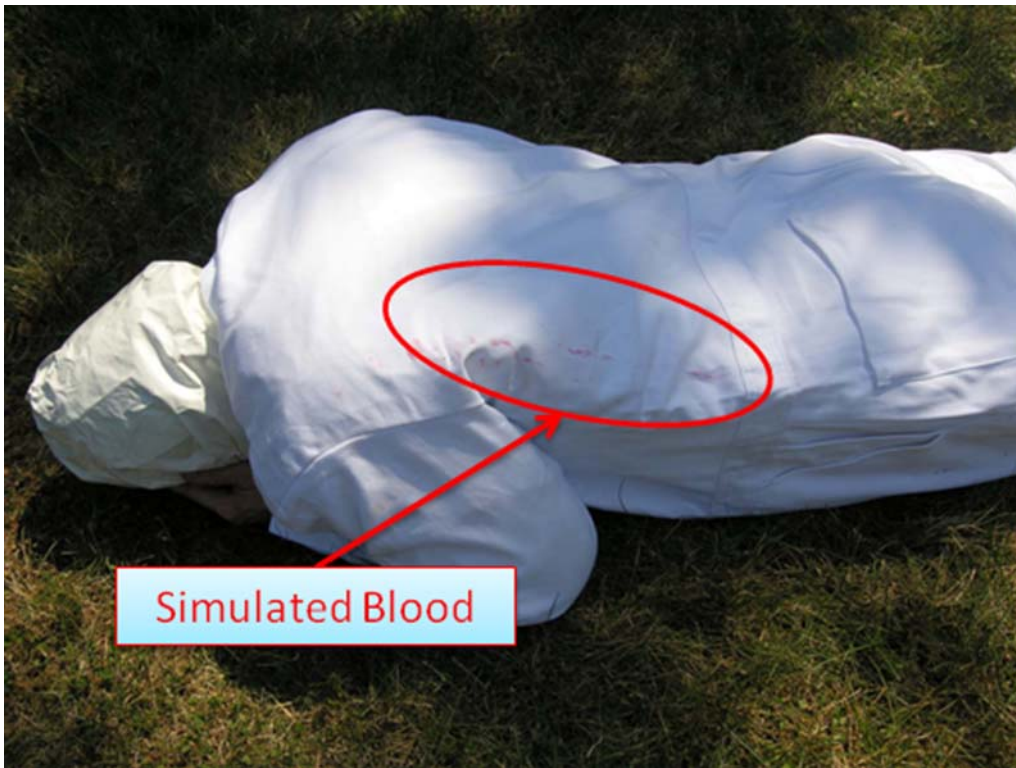
Figure 39. Inspection of the victim's back after Scenario 4ab. A small amount of simulated blood was found on the victim's back.

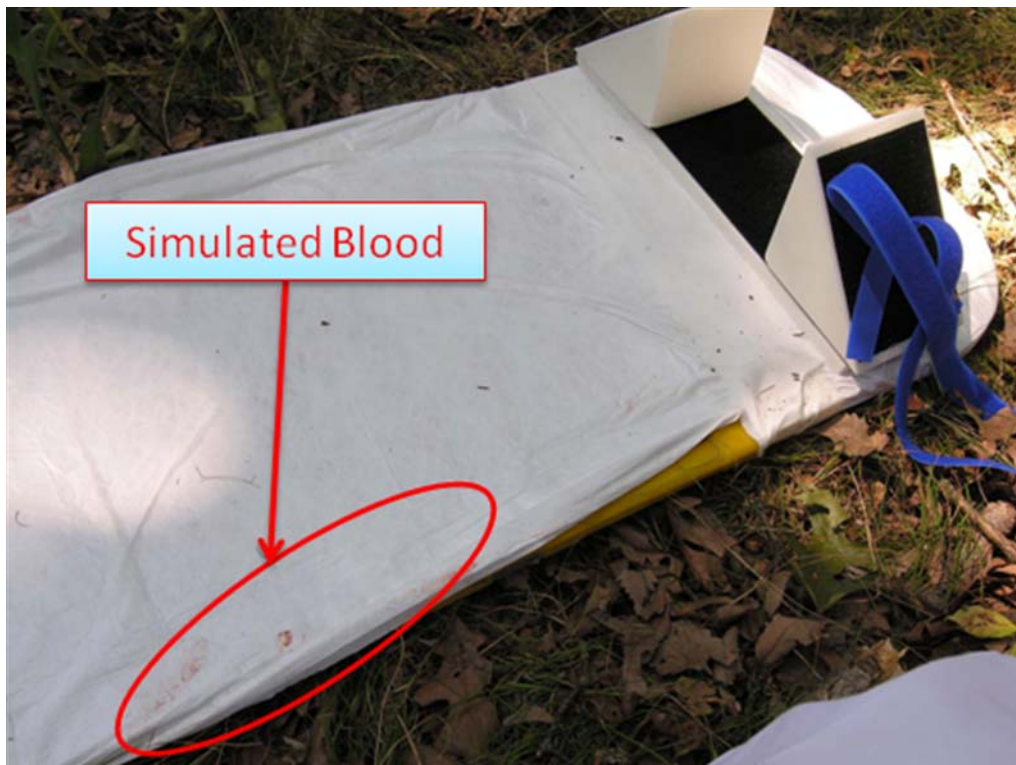
Figure 41. Inspection of the covered backboard after completion of Scenario 4ac. Minor simulated blood was found.

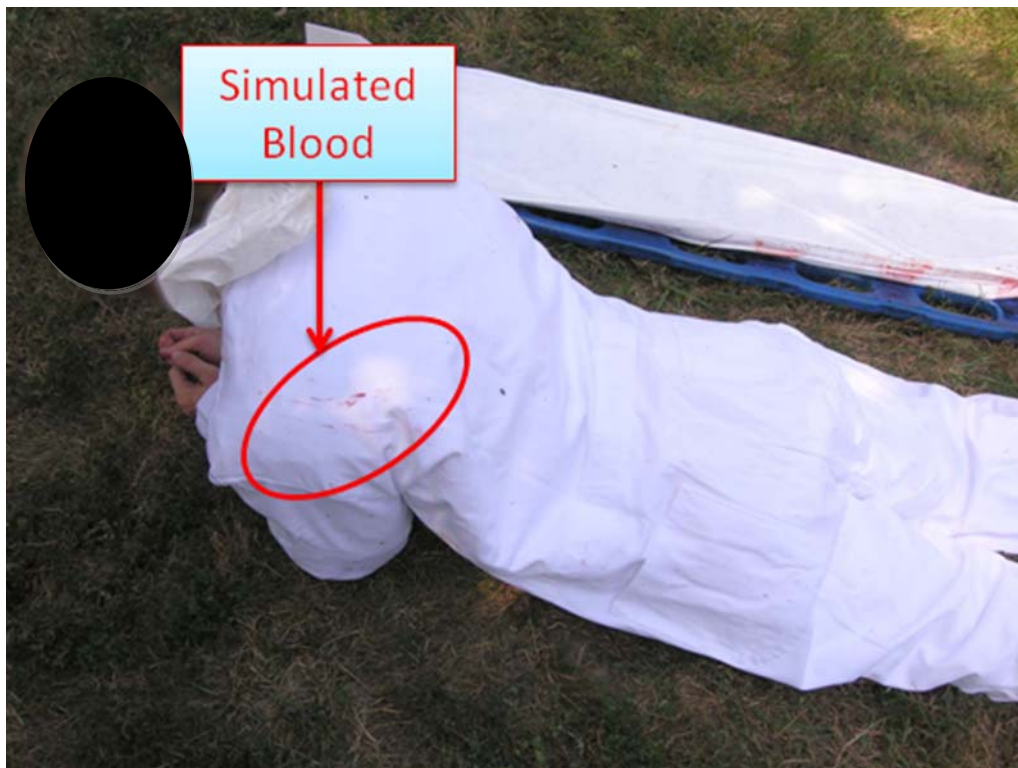
Figure 44. Inspection of the covered backboard and the victim's back after the completion of Scenario 4b. Minor simulated blood spot were found on the victim's shoulder.

- The adhesive was not as sticky, but it still held and worked well during the test
- There were no differences in applying the backboard cover to the new model backboard used during this test from the procedures used for the previous backboards
- The victim could not tell the difference from a standard uncovered backboard and a covered backboard while being transported.
- There was a small amount of simulated blood found on the victim's shoulder

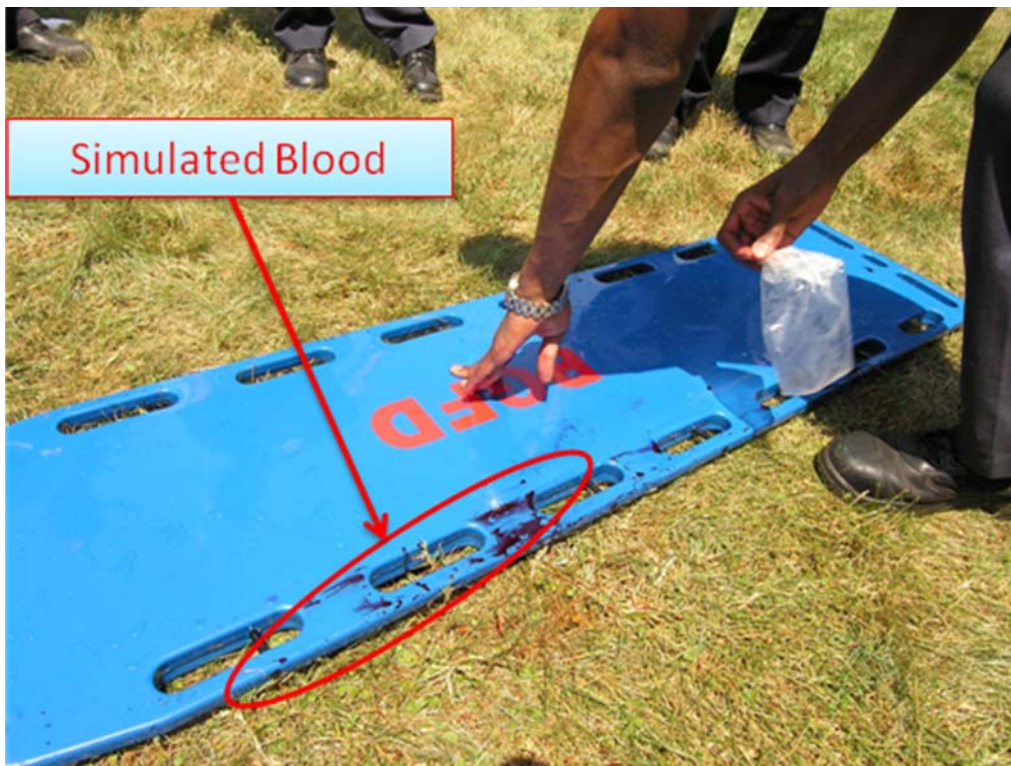
Figure 47. Inspection of the backboard after completion of Scenario 5a. A small amount of simulated blood was found at the edge of the backboard.

- There was no slippage while the victim was being transported
- There was a small amount of simulated blood found on the edge of the backboard

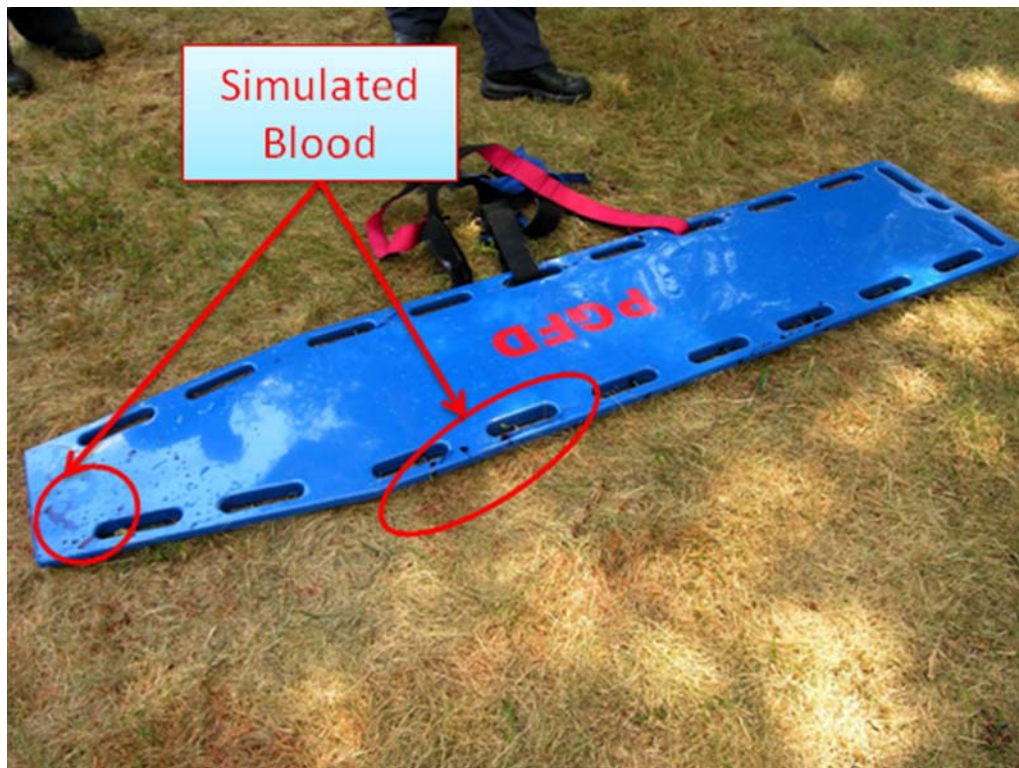
Figure 50. Inspection of the backboard after completion of Scenario 5b. A small amount of simulated blood was found on the edge of the backboard.

- There was no slippage while transporting the victim
- There was some simulated blood found at the edge of the backboard

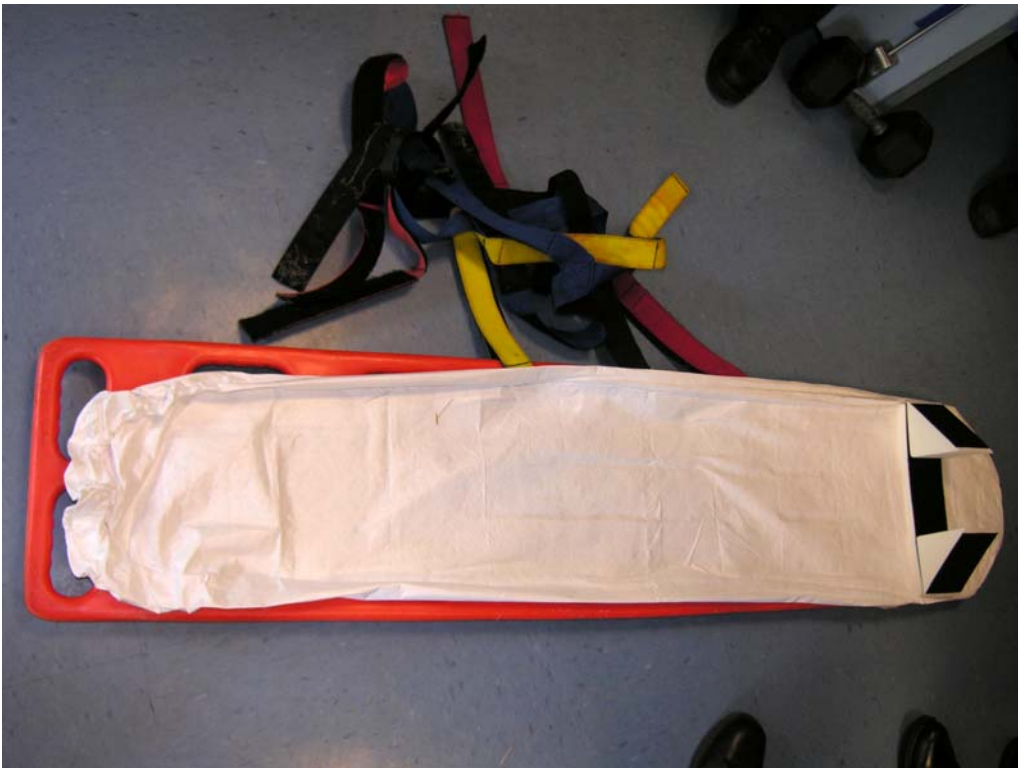
Figure 53. View of the backboard after the completion of Scenario 6. No damage was observed.

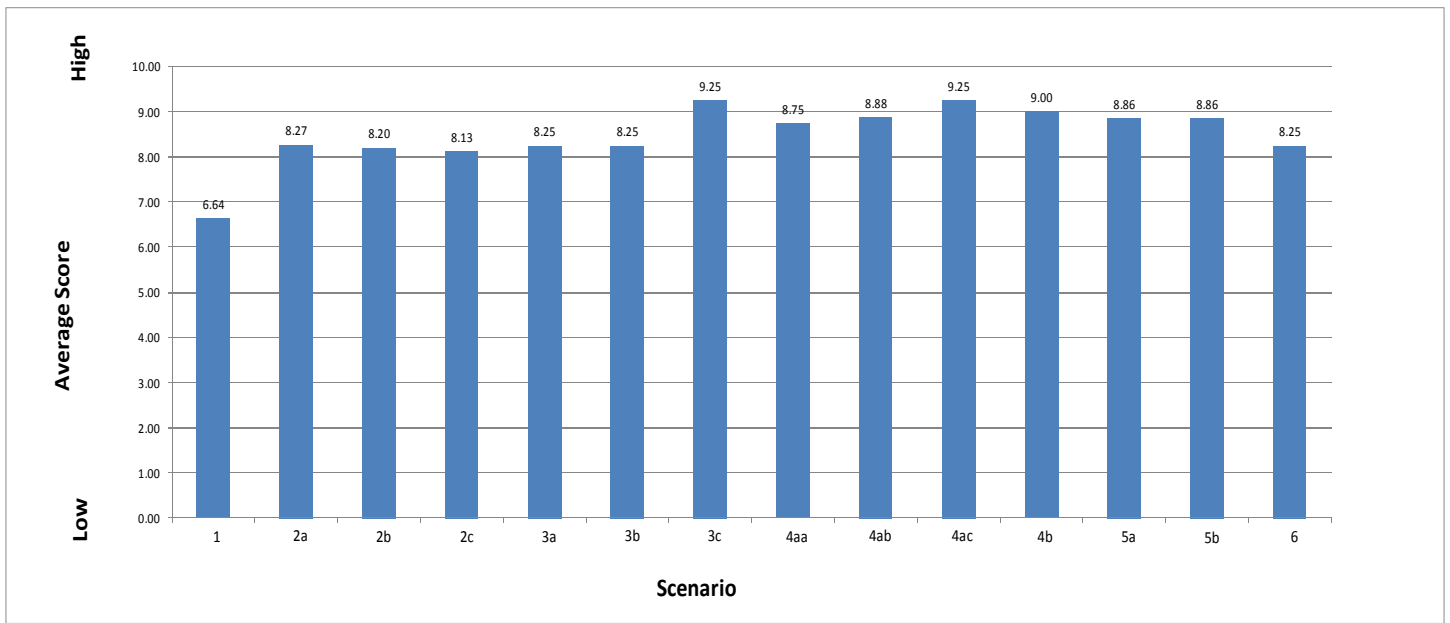
Figure 54. Average Score vs. Scenario Chart for the Function: Un-packaging and applying the backboard cover.
