**FINAL REPORT: CULTURAL RESOURCES SURVEY OF APPROXIMATELY 54 ACRES FOR THE SAN DIEGO SECTOR BORDER WALL PROTOTYPE, U.S. CUSTOMS AND BORDER PROTECTION, SAN DIEGO SECTOR, SAN DIEGO COUNTY, CALIFORNIA**

**PROJECT NAME/NUMBER:** San Diego Sector (SDC) Border Wall Prototype Cultural Resources Survey, Gulf South Research Corporation (GSRC) Project No. 80335101g

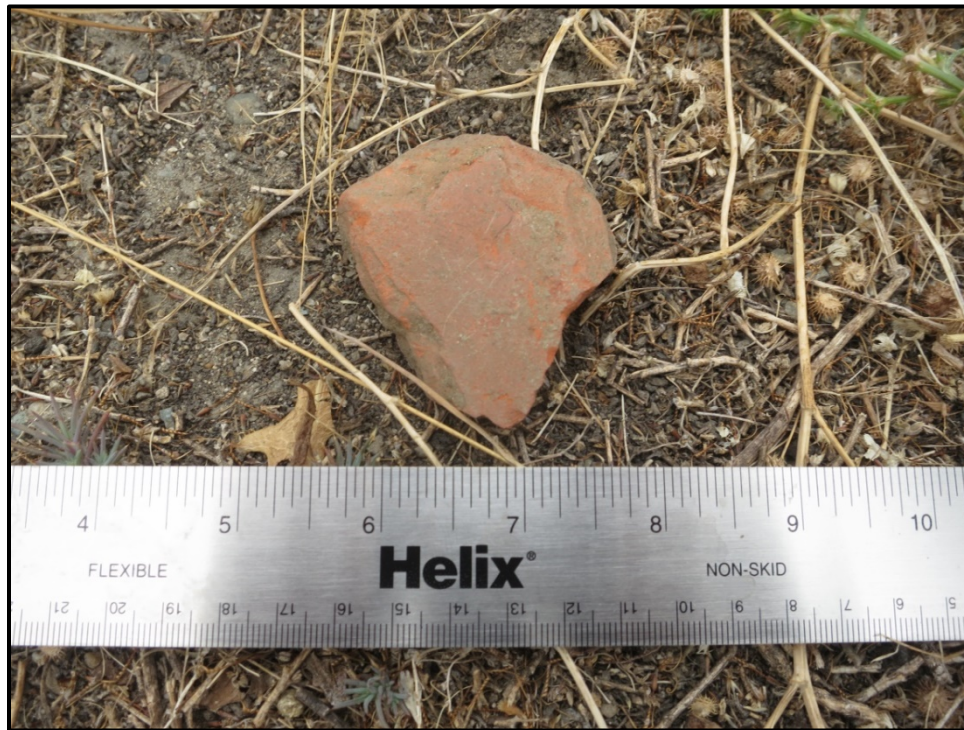
GSRC Archaeologist (b) (6) inventoried the project area on August 23, 2017, by inspecting the ground surface of the proposed 54-acre project area and immediate surroundings using parallel transects spaced no more than 20 meters apart. No archaeological sites or historic properties were identified during the pedestrian archaeological survey. Furthermore, there was no evidence at all of the previously recorded sites, confirming that the previous sites were collected or tested out of existence (Figure 7). The project area itself has been heavily modified through earth-moving activities and development of the surrounding area. Several features were observed, such as a drainage channel and storm drain, but have been determined to be modern in origin (i.e., within the last 10 to 20 years). A fragment of a ceramic roof tile was also noted within the 10-acre potential staging area (GSA lot) (Photograph 1), but appears to be displaced, along with other modern refuse, and is likely modern itself.

**Photograph 1. Ceramic roof tile fragment in GSA lot**

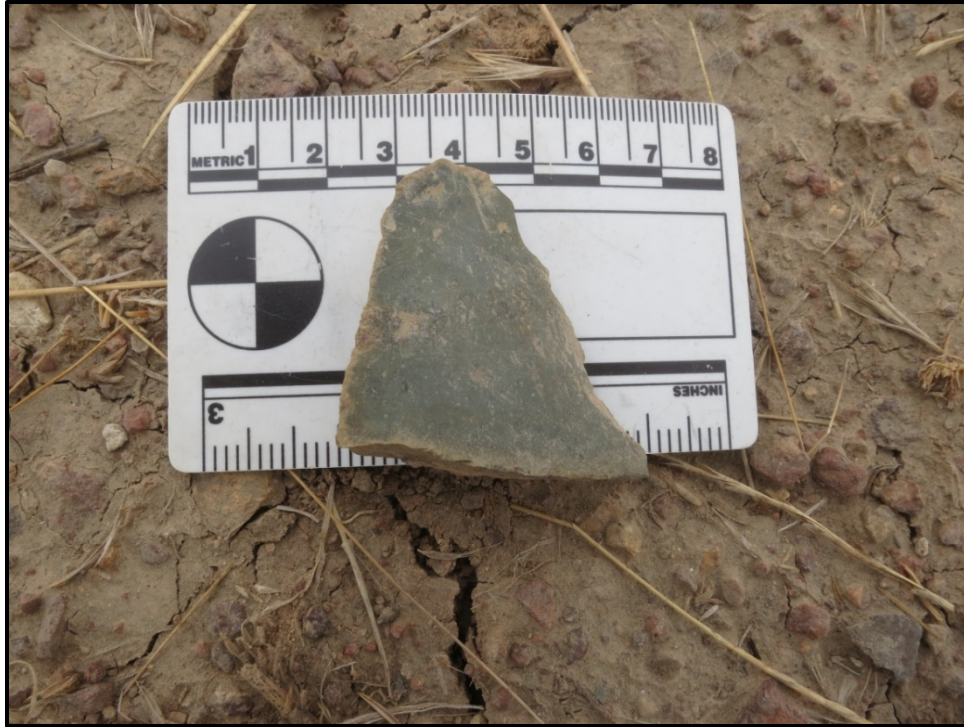
In addition, two possible pieces of lithic debitage were also noted (Photographs 2 and 3). Both items are located between the primary fence and the all-weather road to the north, and within an area that has been subject to significant earth-moving activities (e.g., blading, grading, leveling). It is common for heavy equipment passing over rocks to create “pressure or percussion” flakes analogous to prehistoric flint knapping techniques, when the raw material has the property of conchoidal fracture. Furthermore, the parent material of the “possible flakes” was similar to rip-rap and other local material imported for border-related infrastructure projects. Machine-made/caused fracturing of natural rocks also tends to lack certain well-defined morphological characteristics, such as a grinding platform and bulb of percussion. Both “artifacts” were therefore determined to be modern in origin.

**Photograph 2. Example of modern “flake”.**

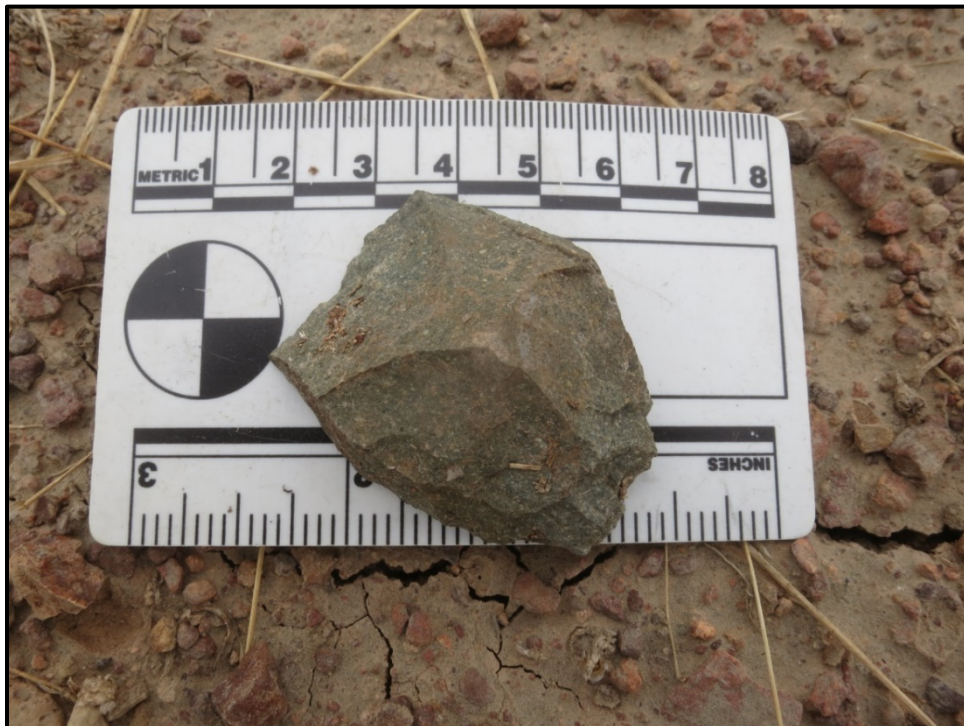
**Photograph 3. Example of modern “flake”.**
